# Portland Cement Pervious Concrete Pavement: Field Performance Investigation on Parking Lot and Roadway Pavements

## Final Report

December 1, 2007

Report to the RMC Research & Education  
Foundation

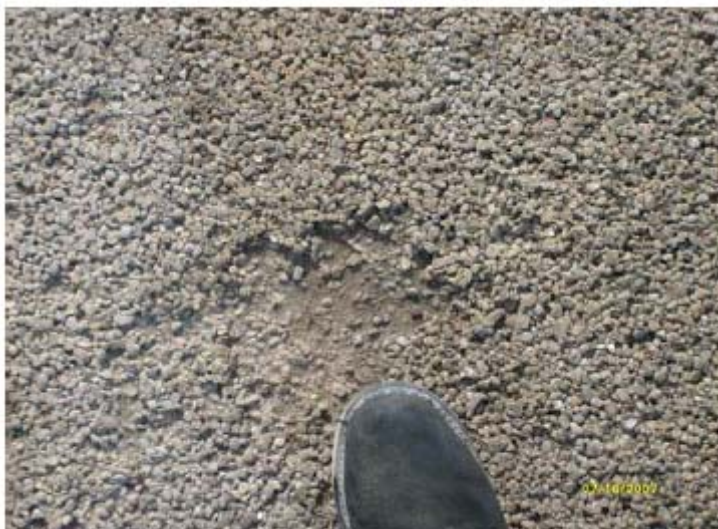
The extent of raveling on the surface and along joints was observed and described as minimal, medium (significant) or high (extensive). The surface was also examined for cracks and visual indications of clogging. Owners were questioned about maintenance. Figure 3 illustrates an example of surface raveling observed in the field.

**Figure 3: Surface raveling (observed at Charter School, Gary, Indiana)**

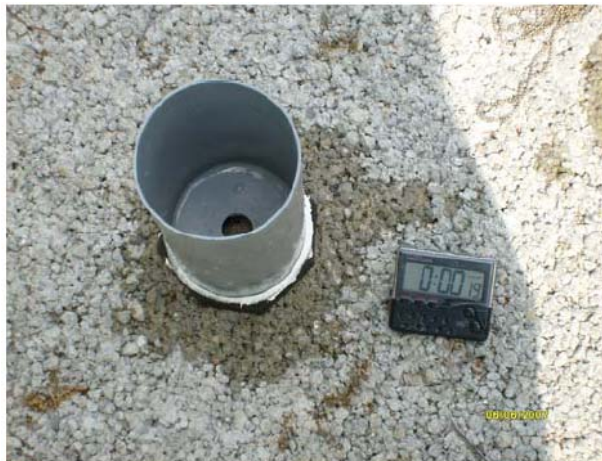
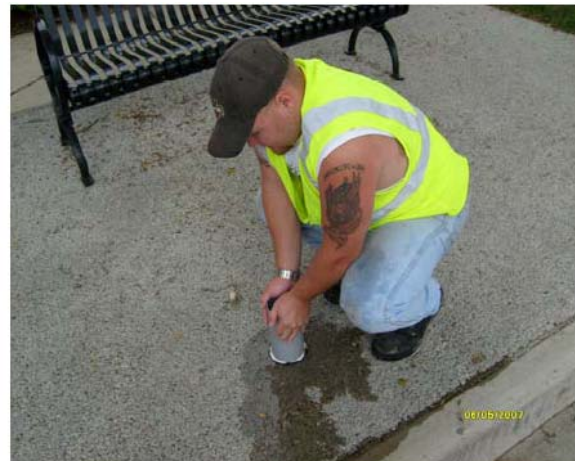
The time to drain the cylinder into the pavement through the hole was measured. Care should be taken not to allow water to freely flow around the parameter of the mold. Thus, pressure should be applied on top of the mold during testing. The test may also be used before and maintenance to quantify the effectiveness of a maintenance technique. As part of this research, drain time was calibrated to hydraulic conductivity. The best-fit equation is provided in Chapter 6. Hydraulic conductivity is often called permeability in pavement engineering.

**Figure 4: Drain time Apparatus**

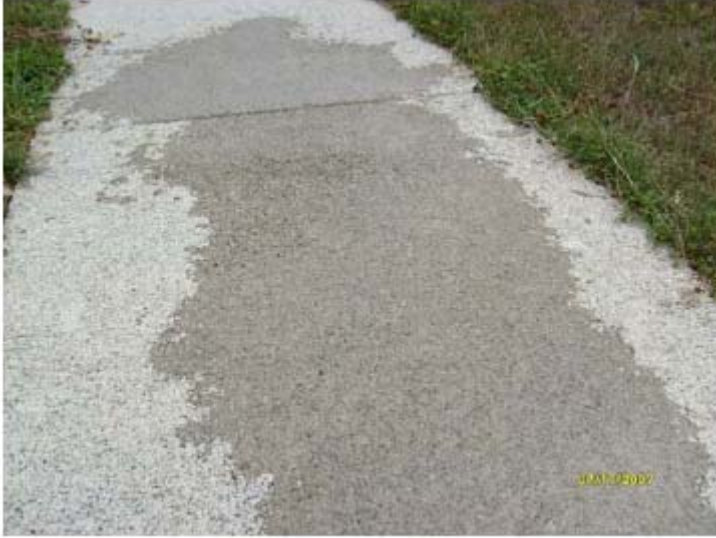
Maintenance of pervious concrete typically consists of vacuuming and/or pressure washing. Pressure washing may drive sediment further into the pores of pervious concrete. Prior to performing any maintenance on pervious concrete, it is first necessary to determine if the surface is clogged, and to what extent.

**Figure 5: Sheet flow across clogged surface (observed at Rieth Village, Albion, Indiana)**

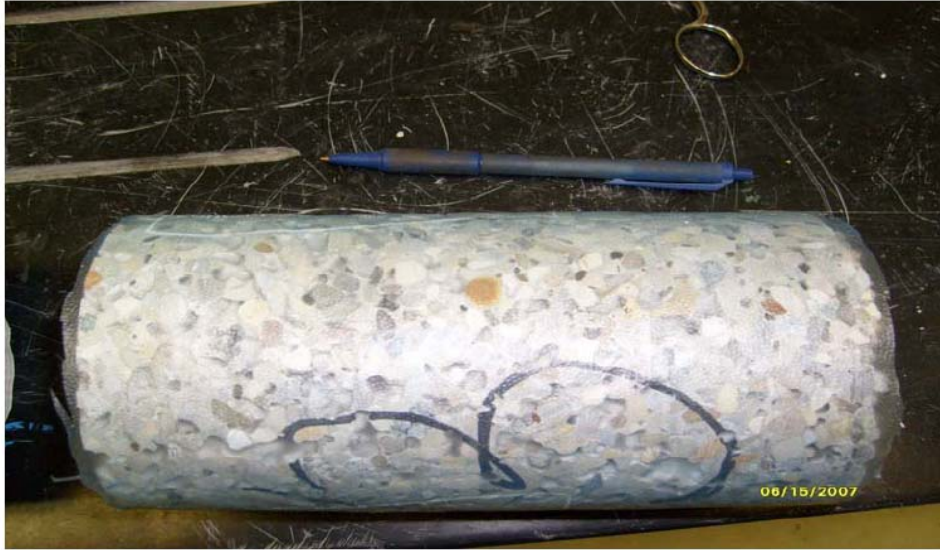
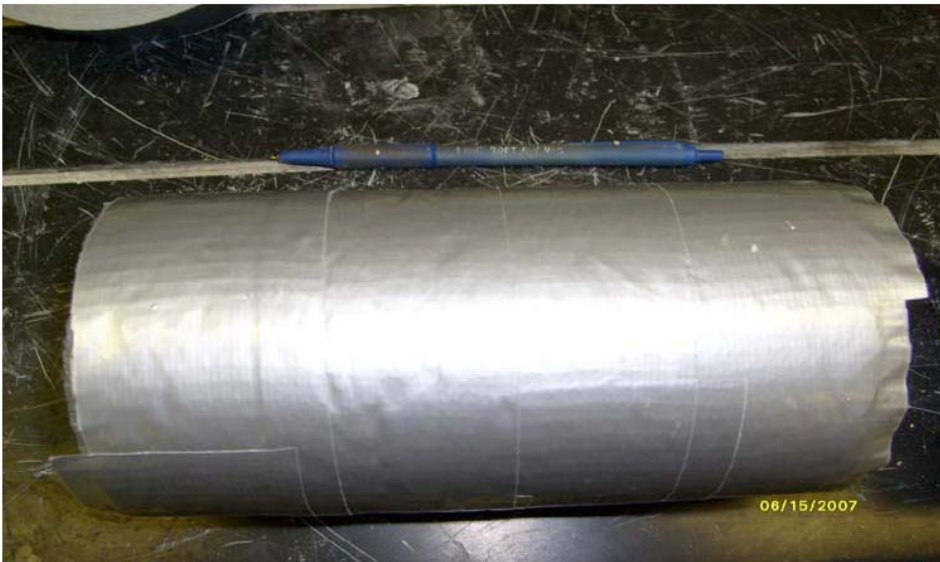
Samples tested for hydraulic conductivity were sliced in half, and hydraulic conductivity was repeated on the top and bottom parts. Later, the top and bottom parts were tested in splitting tension. Specimens were prepared by wrapping them in plastic and then in duct tape, as shown in Figure 6.

**Figure 6: Sealed specimen for hydraulic conductivity testing**

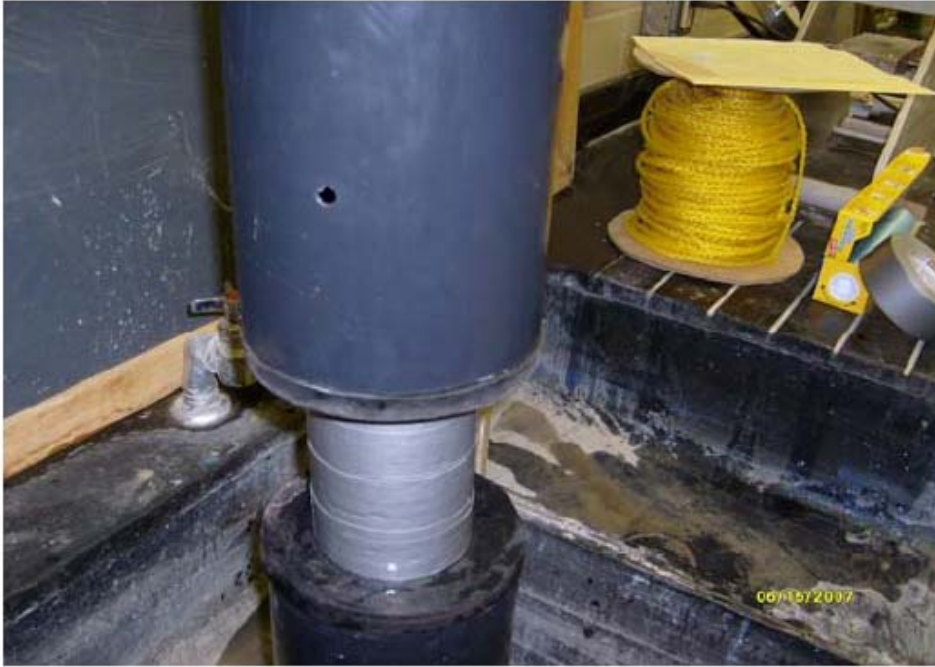
**Figure 7: Laboratory hydraulic conductivity testing**

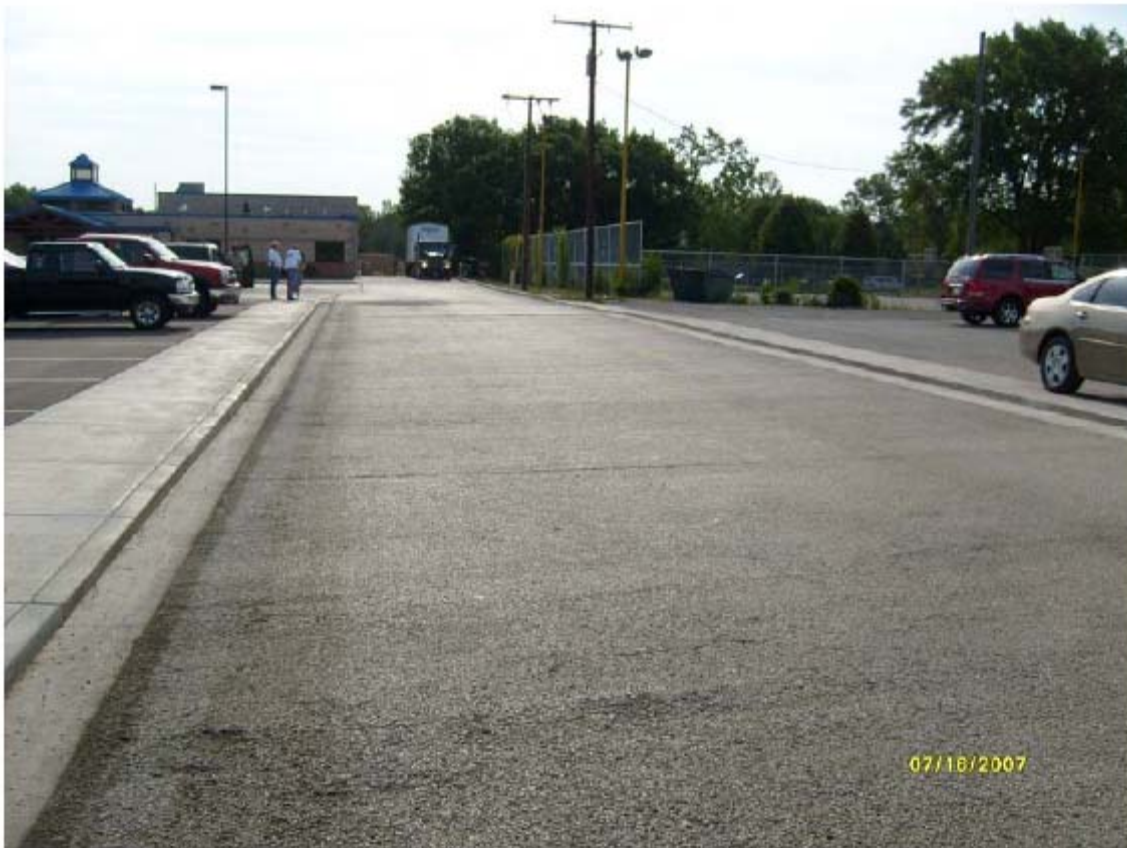
**Figure 8: Charter School, Gary, Indiana**

This charter school uses pervious concrete pavement for a parking lot and driveway. The pervious driveway begins approximately 30 ft from Clark Road, and leads back to the parking area for the school, as shown in Figure 8. This pavement was built in July, 2006.

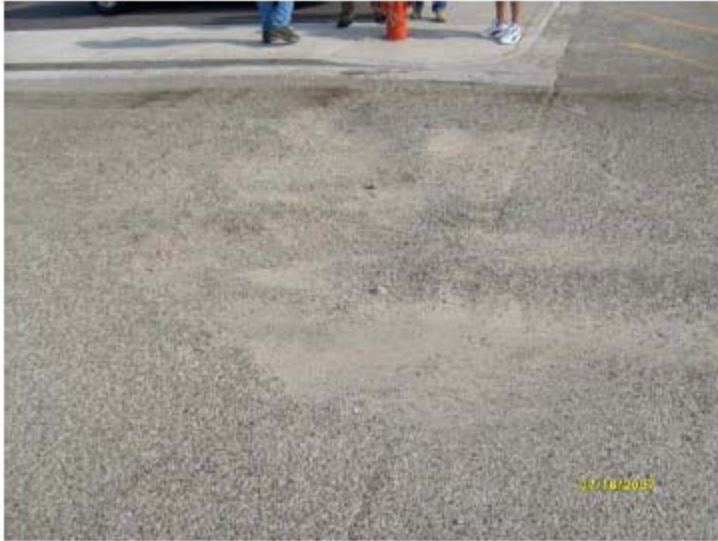
The pervious concrete parking area is sloped to the center, where there is conventional concrete with three storm drains to catch any water or debris. There is also a fire hydrant near the northwest corner of the parking lot. This hydrant is significant because of the firehouse that is adjacent to the charter school. The fire department uses this hydrant to fill their fire truck with water, and also flushes the hydrant regularly. The school has also begun renovations, so construction vehicles and other delivery vehicles also frequently cross the pervious concrete. This area also is subjected to school bus traffic. The area of damaged pervious concrete is shown in Figure 9.

**Figure 9: Surface damage from heavy vehicles near fire hydrant**

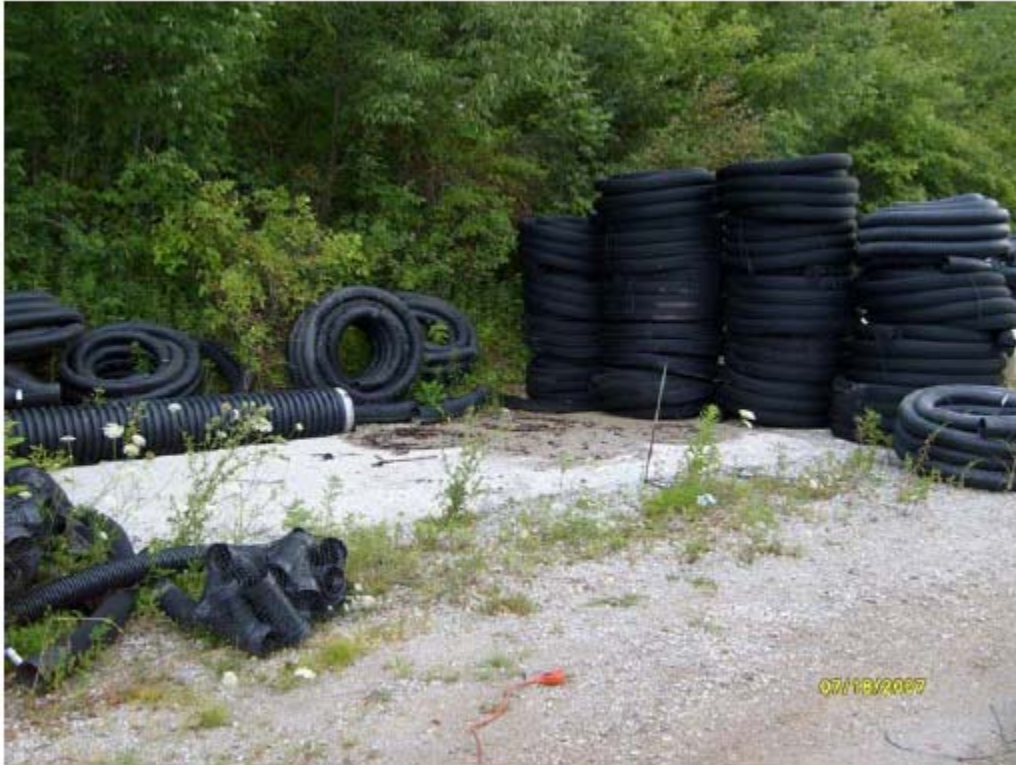
**Figure 10: Keystone Concrete storage pad, Churubusco, Indiana**

This installation is a small storage pad, completed in August 2004. It consists of three test strips of different materials, and is used to store rolls of flexible drainage pipe, as shown in Figure 10. It was placed with an asphalt paver to a thickness of 4 inches, and compacted with a vibratory screed. At present, it is clogged with leaves and other debris. There is no traffic applied to the installation, and there was no observed cracking or raveling. Twelve core samples were removed.

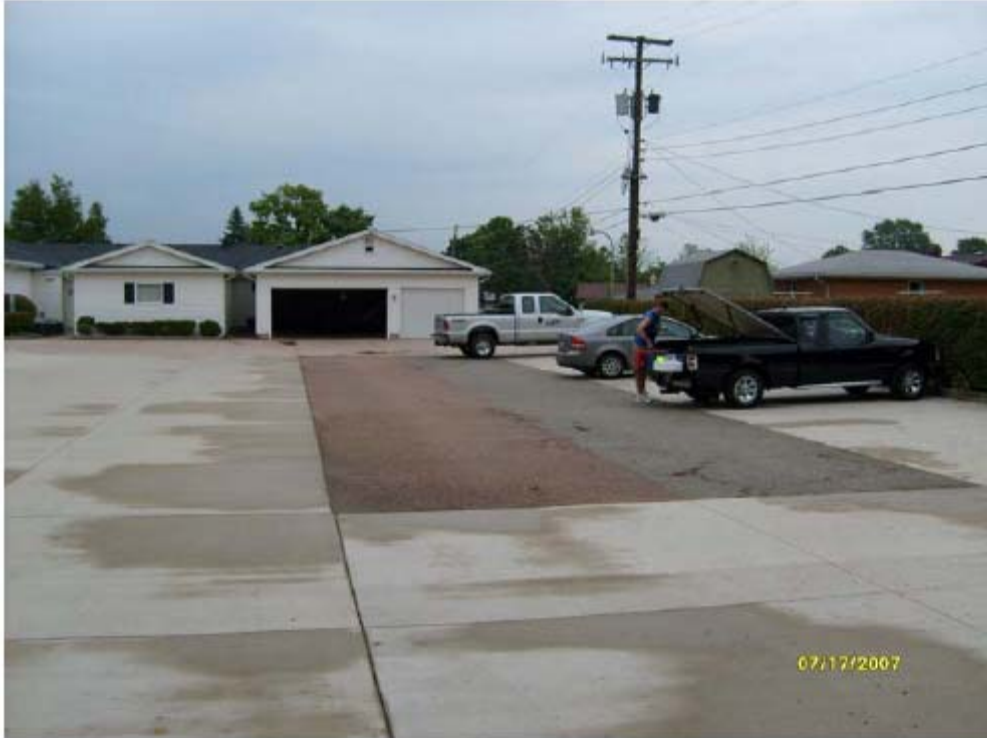
**Figure 11: Kuert Concrete Corporate Office, South Bend, Indiana**

The red strip is clogged with asphalt shingle debris. After installing pervious concrete roof was replaced, and down spouts which empty directly onto the parking lot carried a lot of debris which eventually ended up in the pervious concrete pores. Power washing had not been able to restore the infiltration capability. No other maintenance has been performed so far. The owner plans to remove and replace the red section, and leave the gray section in place.

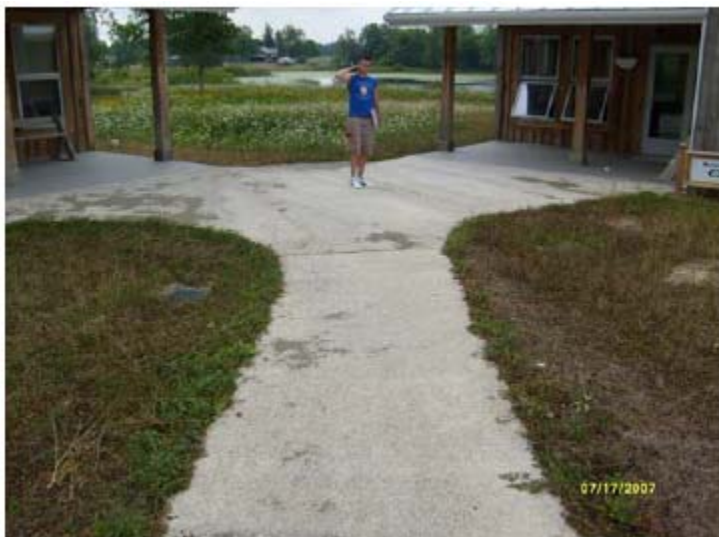
**Figure 12: Rieth Village environmental learning center, Albion, Indiana**

Rieth Village is an environmental conservatory with a platinum LEED rating. It was built in April 2006 by Goshen College as a place where students could live, study, and conduct research. The pervious concrete installation is a sidewalk leading to the learning center, shown in Figure 12.

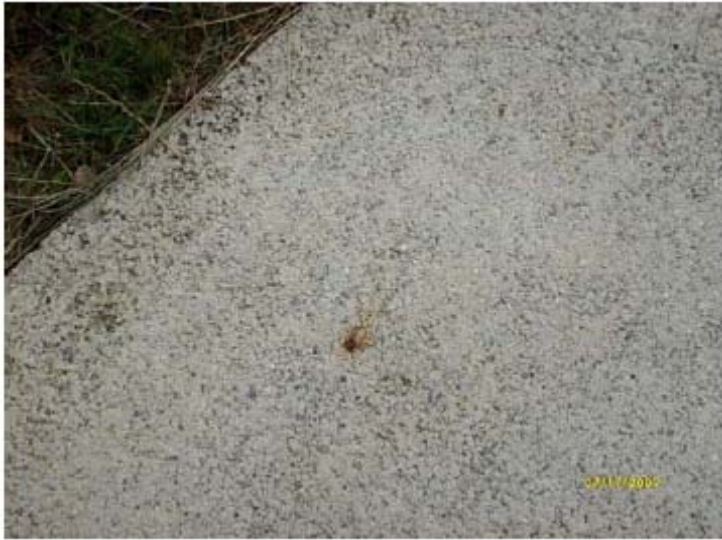
The surface of the sidewalk appears to have been sealed off during construction, either due to a wet mixture or over compaction. The sidewalk is shown in Figure 13. Due to the uneven terrain, it was difficult for the installers to use a Bunyan Screed. The concrete supplier also observed that the mixture may have been too wet. Water dumped onto the surface flowed across the pavement, not into it, as shown in Figure 5. There was no observed raveling. One crack was found at the intersection of three paths. To date, no maintenance has been performed.

**Figure 13: Surface sealed by wet mixture or over compaction**

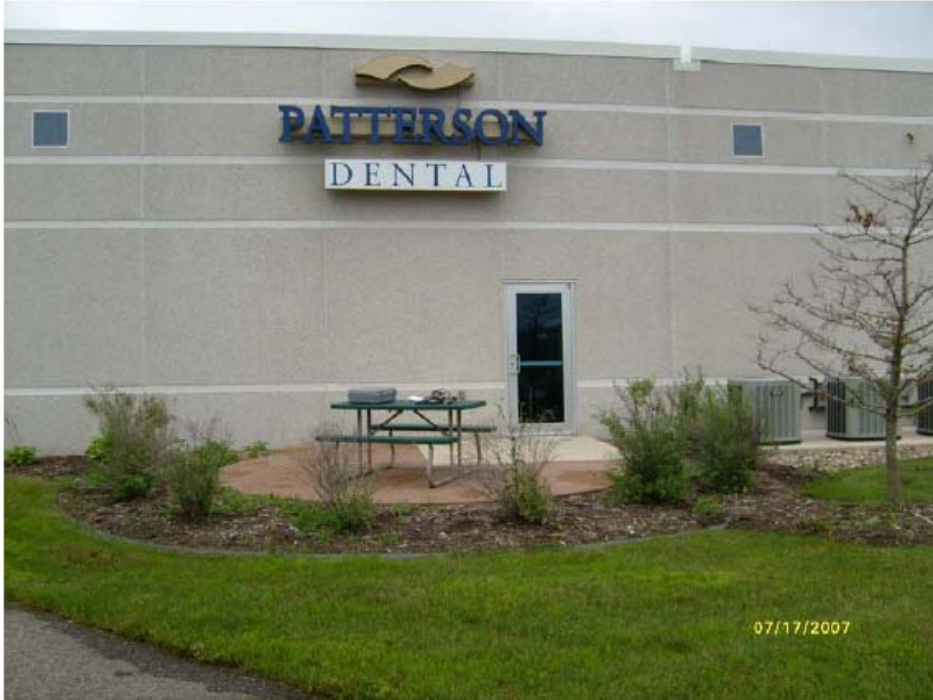
**Figure 14: Patterson Dental Supply pervious concrete patio**

The Patterson Dental Supply installation is a small patio behind the building, as shown in Figure 14. The patio was completed in June, 2004. This installation drains well and does not show any clogging. Minor aggregate polishing, raveling, and cracking were observed. One crack starts at a re-entrant corner, which would be expected. No maintenance has been performed to date.

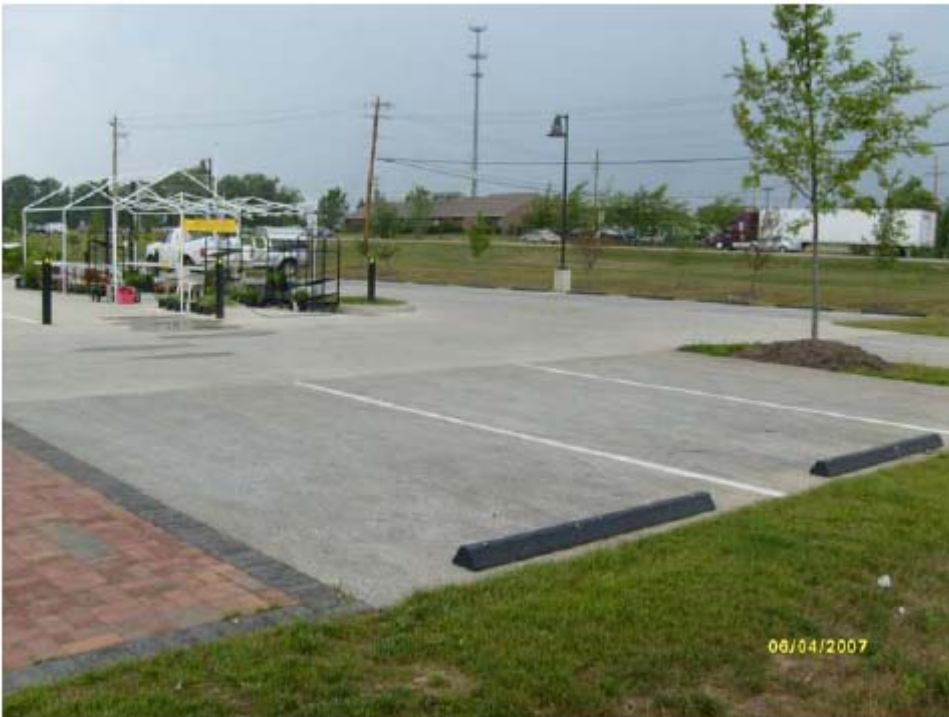
**Figure 15: Boone County Farmer's Market, Burlington, Kentucky**

The Boone County Farmer’s Market parking stalls were placed in January 2006. This pavement is shown in Figure 15. The overall design uses conventional concrete for the driving surface and shopping area, brick for some of the decorative areas, and pervious concrete for the parking stalls. A Bunyan Screed was used. Much of the pervious concrete is clogged with silt, and some portions were over compacted during installation. Some raveling was observed, particularly at joints. One crack was found, which may be due to overloading by a heavy landscape truck. No maintenance has been performed. Overall, this installation drains well.

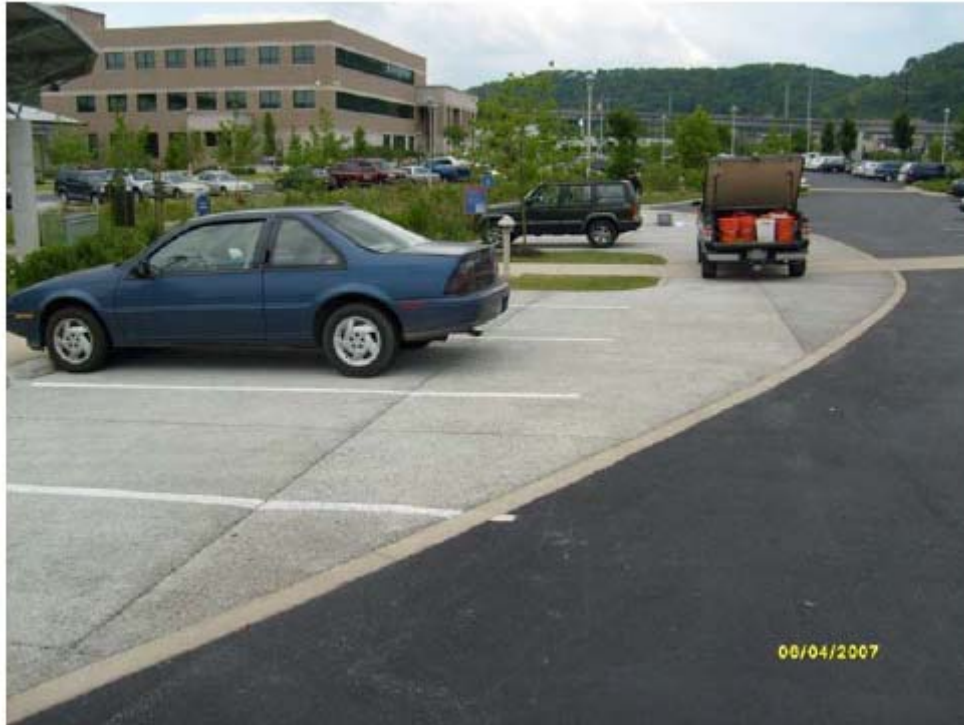
**Figure 16: Kentucky Sewer Sanitation District #1, Fort Wright, Kentucky**

This parking lot installation, shown in Figure 16, was completed in January 2004. Most of the pavement is asphalt, with pervious concrete parking stalls. The parking lot also includes an engineered wetland. This parking lot has light to moderate clogging from debris. Part of the lot was also sealed by over compaction during construction. The parking lot has been vacuumed twice to remove loose surface aggregate and maintain infiltration capability. There is no cracking, but there is some minor raveling and polishing of the surface.

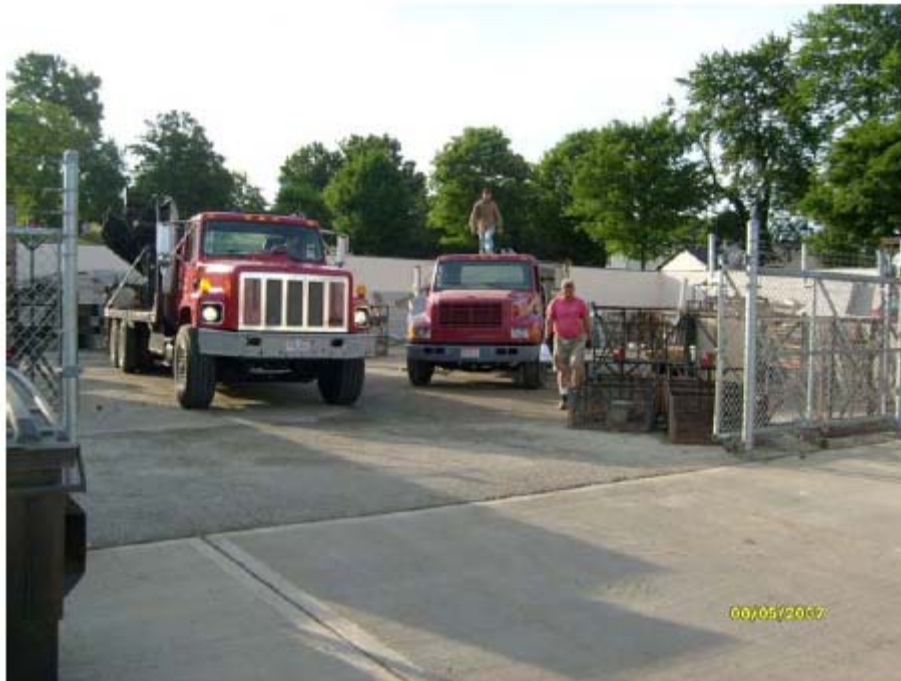
**Figure 17: Ball Brothers Contracting, Monroe, Ohio**

There are also two cracks, possibly caused by heavy vehicles. The only maintenance applied has been snow and ice removal, which caused some abrasion of the surface. The extent of clogging suggests that power washing or vacuuming should be attempted to restore infiltration capability.

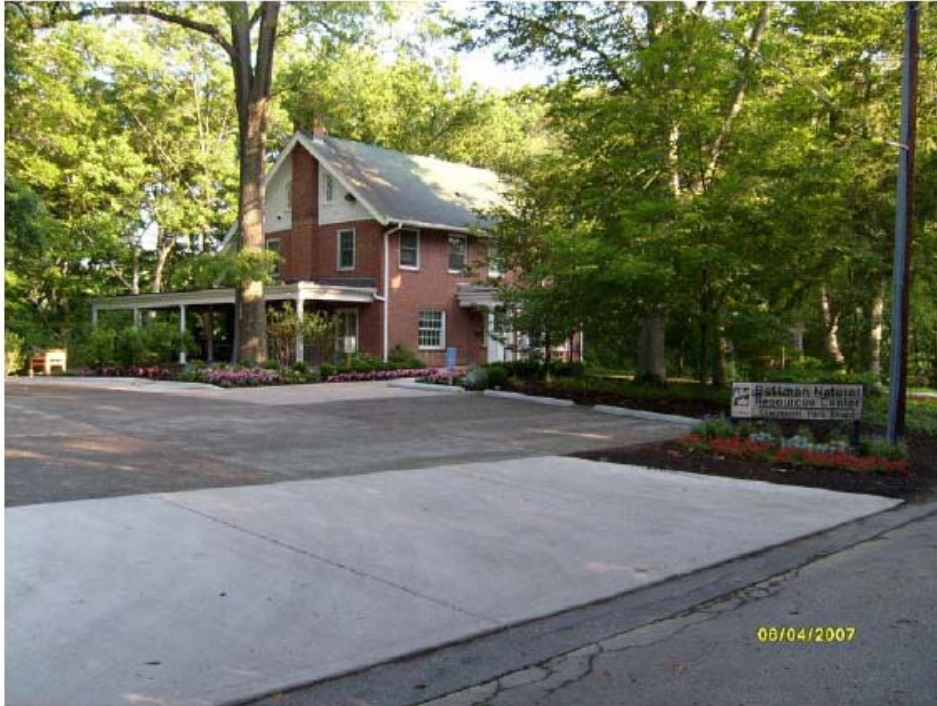
**Figure 18: Bettman Natural Resource Center parking lot, Cincinnati, Ohio**

The Bettman Natural Resource Center, part of the Cincinnati park district, placed a pervious concrete parking lot in October 2006, as shown in Figure 18. The pavement was placed in three distinct sections.

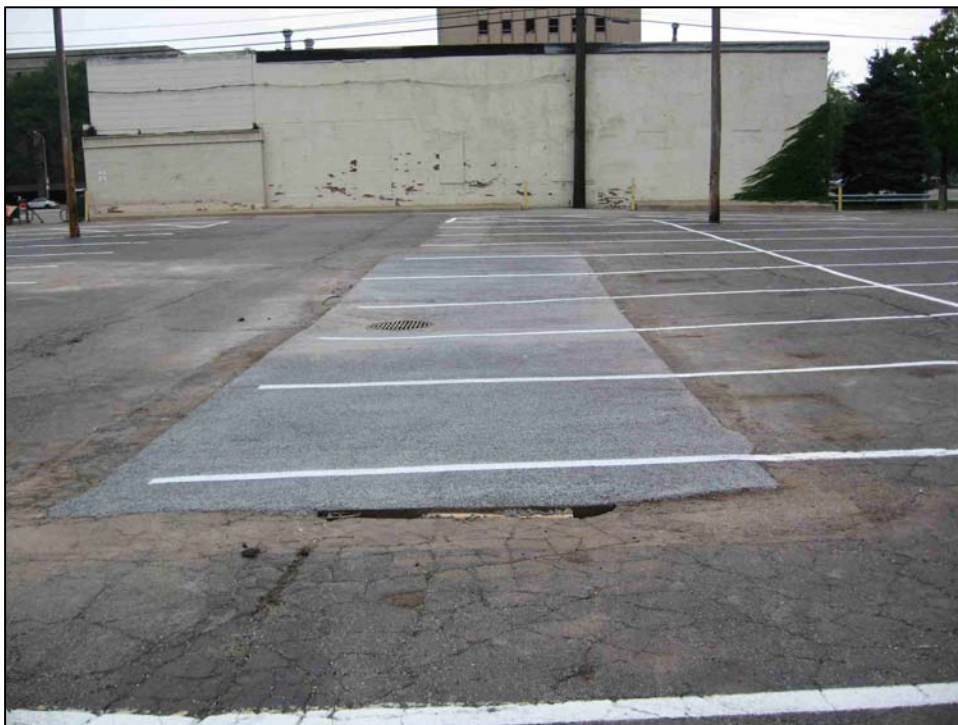
**Figure 19: CSU Parking Lot D Demonstration Project**

On August 22 and 24, 2005, part of an existing asphalt parking lot was removed in order to construct a demonstration pervious concrete pavement site. A 12 by 50 foot (3.66 by 15.2 m) strip of existing parking lot near a drop inlet was removed, and 6 inches (150 mm) of subbase was placed and compacted. On the 22nd, half of the strip was paved with 6 inch (150 mm) thick pervious concrete. Two days later, a seminar and demonstration were held for approximately 200 participants, and the other half of the test section was placed. The installation is shown in Figure 19.

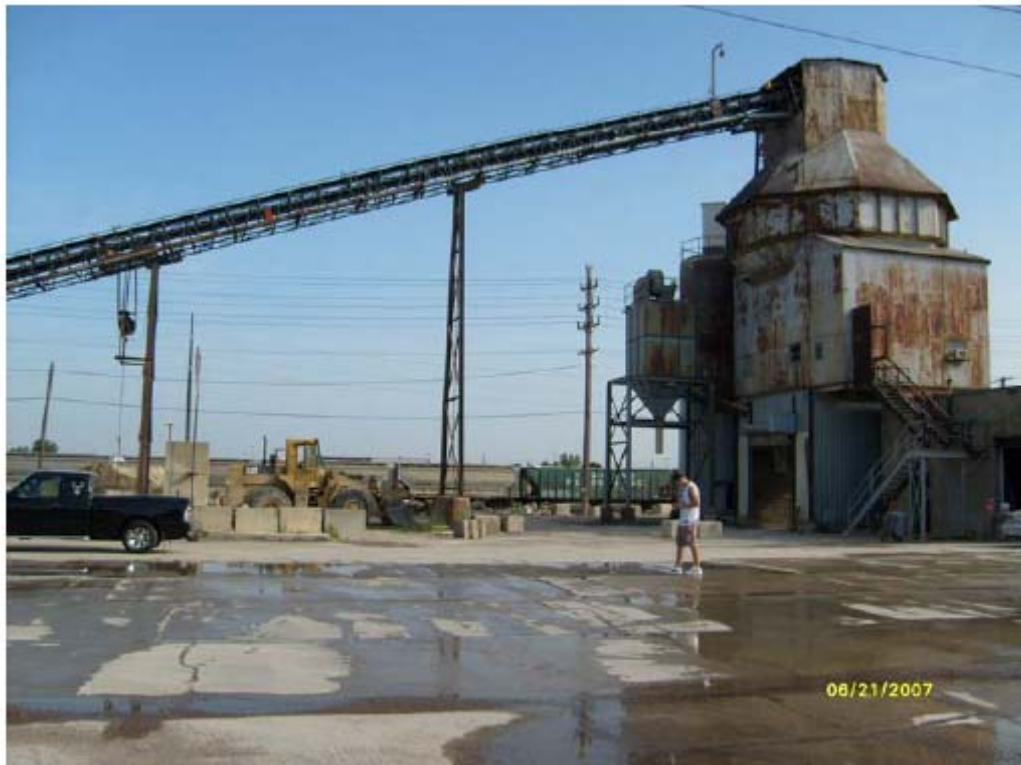
**Figure 20: Collinwood Concrete Saranac Plant, Cleveland, Ohio**

Collinwood Concrete is a major supplier of pervious concrete for projects in and near Cleveland. Their first installation was at their own Saranac plant, Figure 20. This pavement is 9 inches thick and is subject to heavy vehicle loading by concrete delivery trucks. It is also clogged with debris from vehicles and from conventional concrete pavement that drains onto it. Raveling is light to moderate, and there is no cracking. No maintenance has been performed.

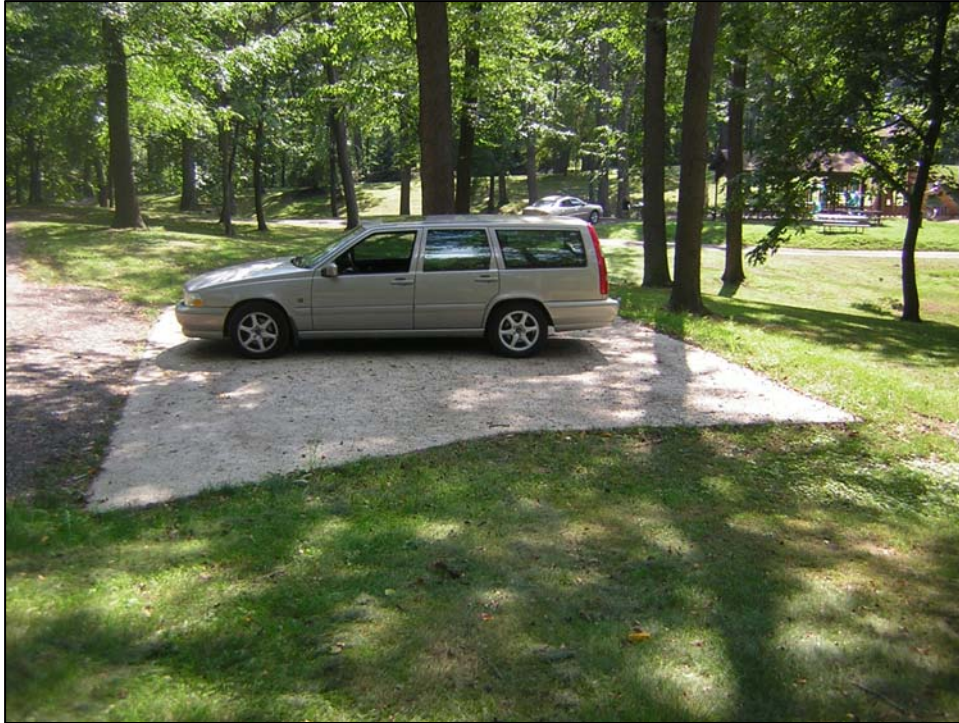
**Figure 21: Fred Fuller Park demonstration project**

The Fred Fuller Park demonstration project (Figure 21) was installed on December 23, 2003, and is the oldest installation in northeast Ohio. It consists of 6 inches of pervious concrete over 8 inches of # 57 base. The parking lot has completed four Northeast Ohio winters without any visible freeze-thaw damage. The surface condition of the project is shown in Figure 22. The two parking stalls receive very light traffic. There is no cracking, and little raveling. No maintenance has been performed.

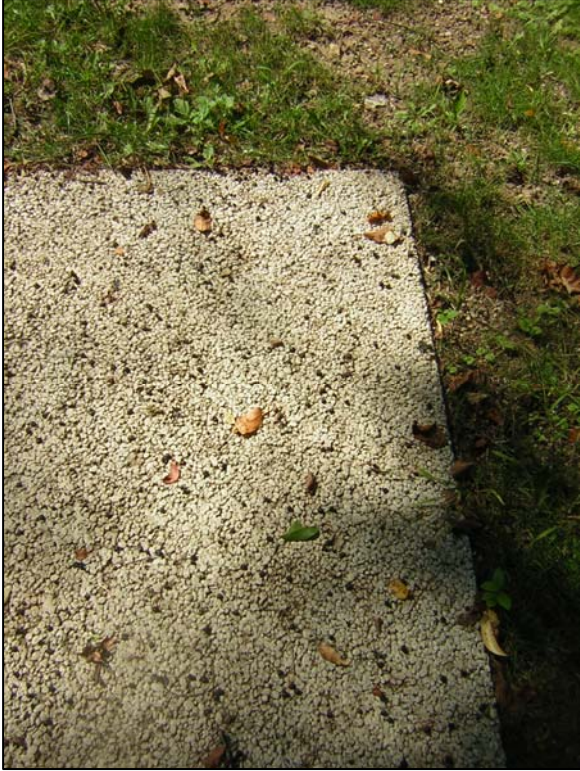
**Figure 23: Harrison Concrete Plant, Harrison, Ohio**

A strip of pervious concrete was placed at the end of the Harrison Concrete Plant office in September, 2006. This installation is shown in Figure 23. It is adjacent to a conventional concrete parking lot, and joints were matched to prevent sympathy cracking. There is some clogging from soil, but little raveling and no cracking.

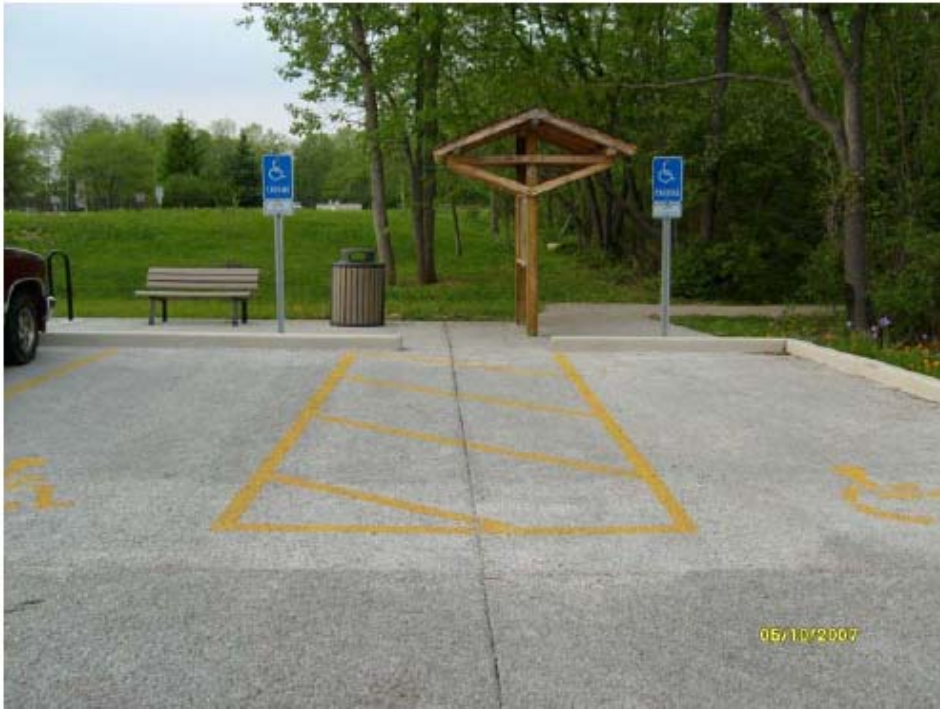
**Figure 24: Indian Run Falls Park, Dublin, Ohio**

Pervious concrete handicapped parking stalls at Indian Run Falls Park are shown in Figure 24. These were placed in May 2006.

Some areas of the pavement surface seem to have been closed off by over-compaction during installation. There is considerable debris on the parking lot. There is also severe raveling, particularly at joints. Some of the surface aggregate has popped off. It does not appear that any maintenance has been performed so far.

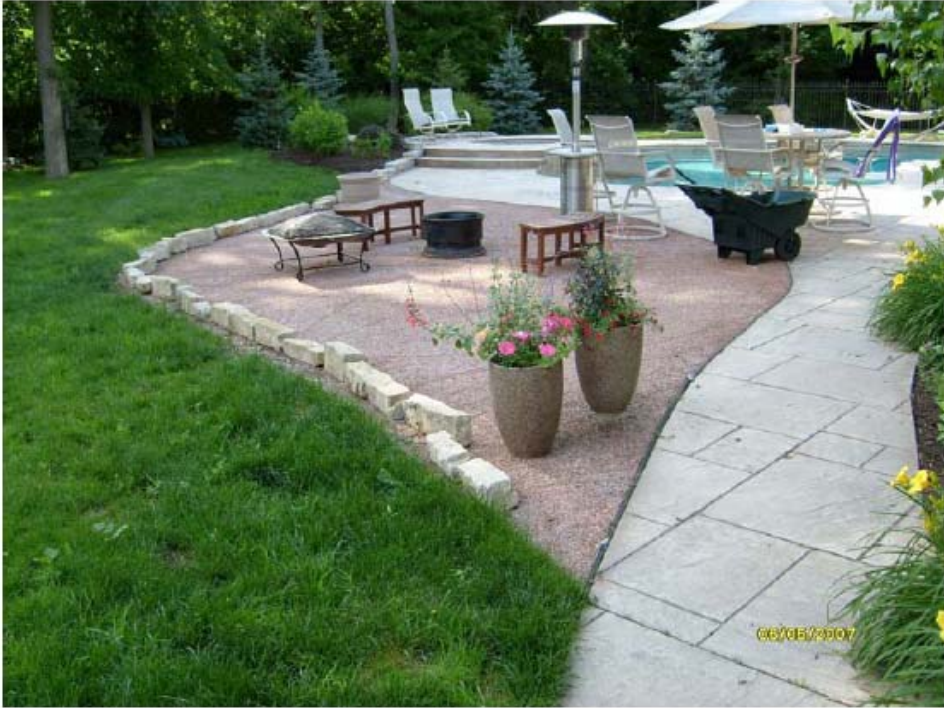
A pervious concrete patio was placed in the location of a persistent wet spot of a private residence in October 2006 (Figure 25). There is very little clogging or raveling so far.

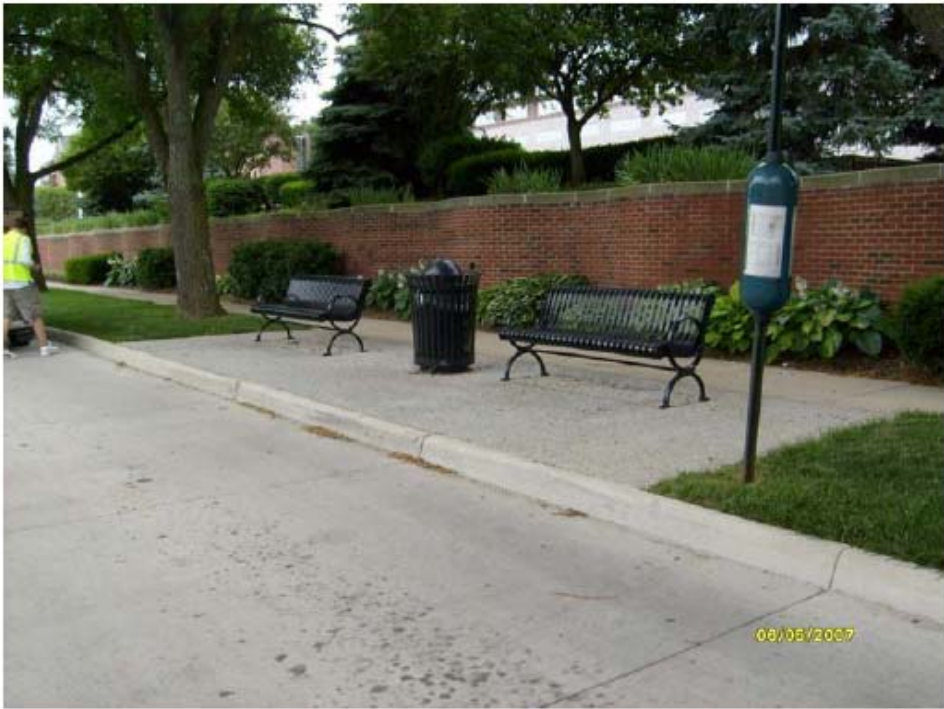
**Figure 26: Bus Stop outside Kettering Memorial Hospital, Kettering, Ohio**

Pervious concrete was installed in September 2004 at a bus stop adjacent to Kettering Memorial Hospital (Figure 26). Although there is no visual evidence of clogging, water flows rather slowly through the pavement. It may have been over-compacted during installation. There is no cracking and very little raveling.

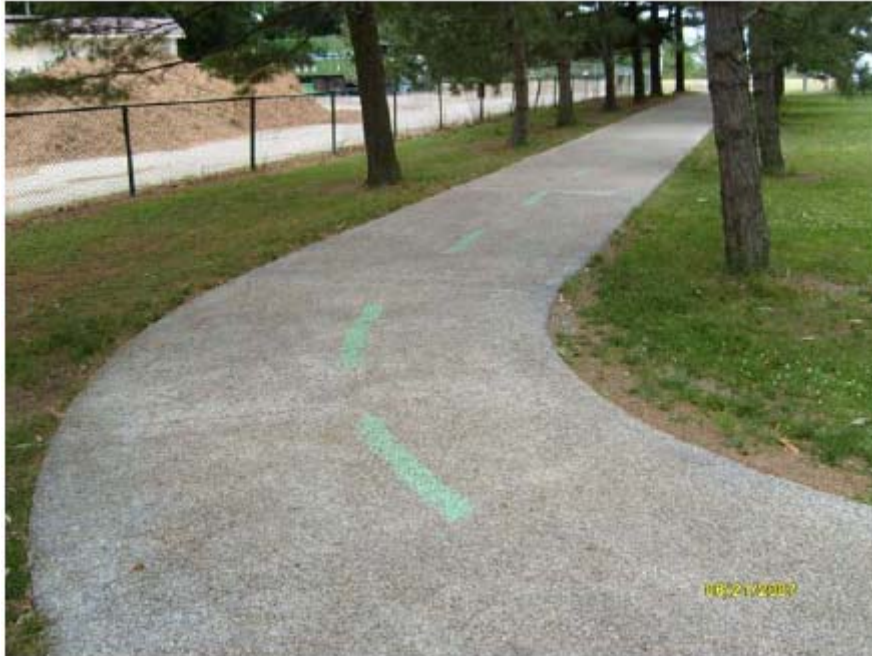
**Figure 27: Park bike path, Lakewood, Ohio**

A bike path in a park on the shores of Lake Erie in Lakewood, Ohio, was placed in November 2005. The path is shown in Figure 27. The pervious concrete was placed to allow water to get to the roots of the trees on either side of the path.

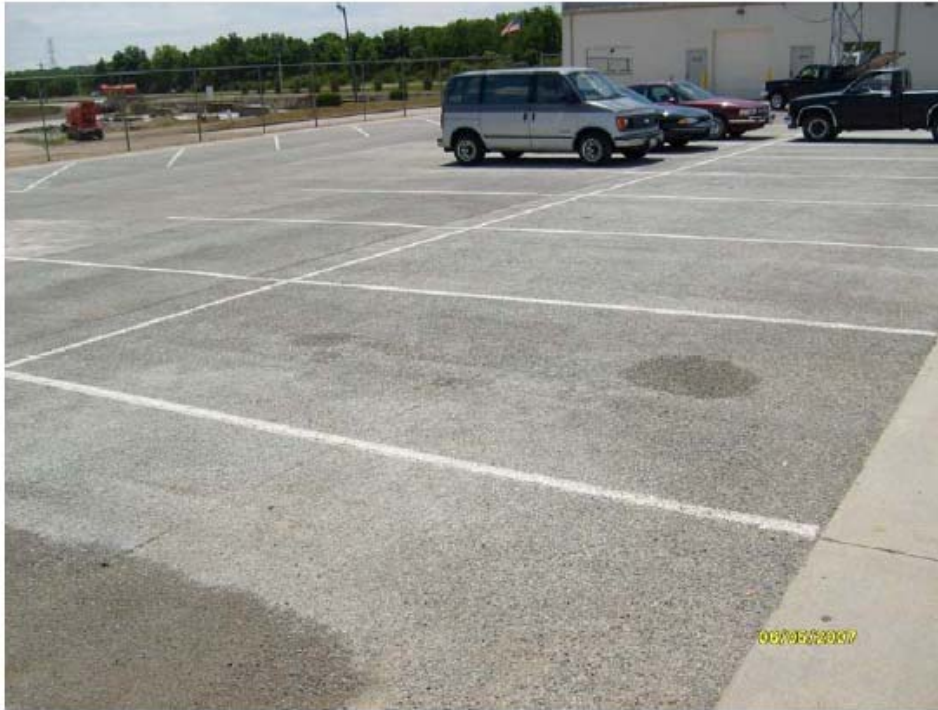
**Figure 28: Phillips Companies parking lot, Beavercreek, Ohio**

Phillips Companies placed a pervious concrete parking lot in January 2006 (Figure 28). A pervious asphalt sidewalk was also installed nearby. A car rental company washes its vehicles adjacent to the pervious concrete strip. There is some light to moderate clogging. Part of the surface also appears to be sealed from over-compaction. There is no cracking, and limited raveling at the joints.

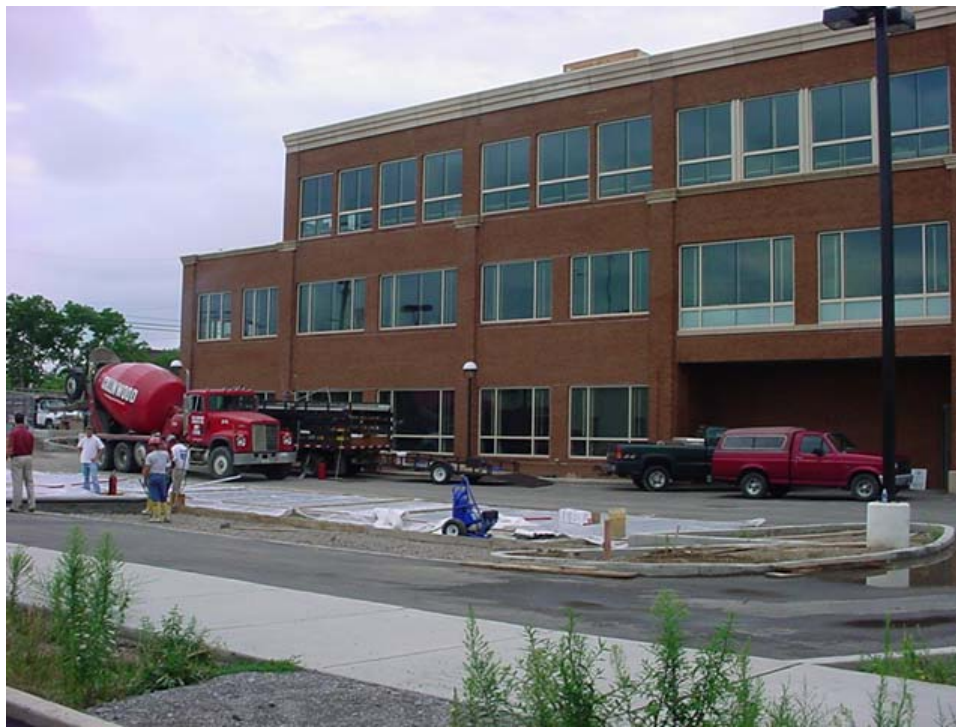
**Figure 29: Cleveland State University Administration Building Parking Lot**

Following the success of Parking Lot D, the Cleveland State University Architect's Office decided to construct a second pervious concrete parking lot on campus, next to the new Administration Building. The original design called for pavers over a stone reservoir several feet thick, but it was estimated that the total cost of a pervious concrete parking lot would be lower because of savings in labor costs. This parking lot was built starting in July 2007, along with another public demonstration. Three placements were made. The second placement is shown in

Figure 29. A colored strip of pervious concrete was placed between the others. Specimens of the concrete delivered were taken to the Cleveland State University laboratories to prepare test specimens.

Approximately seven days after construction, the curing plastic was removed and contractor vehicles began using the parking lot. Because the administration building complex was not yet complete, a significant amount of loose soil has washed on to the pavement, and there is local but severe clogging.

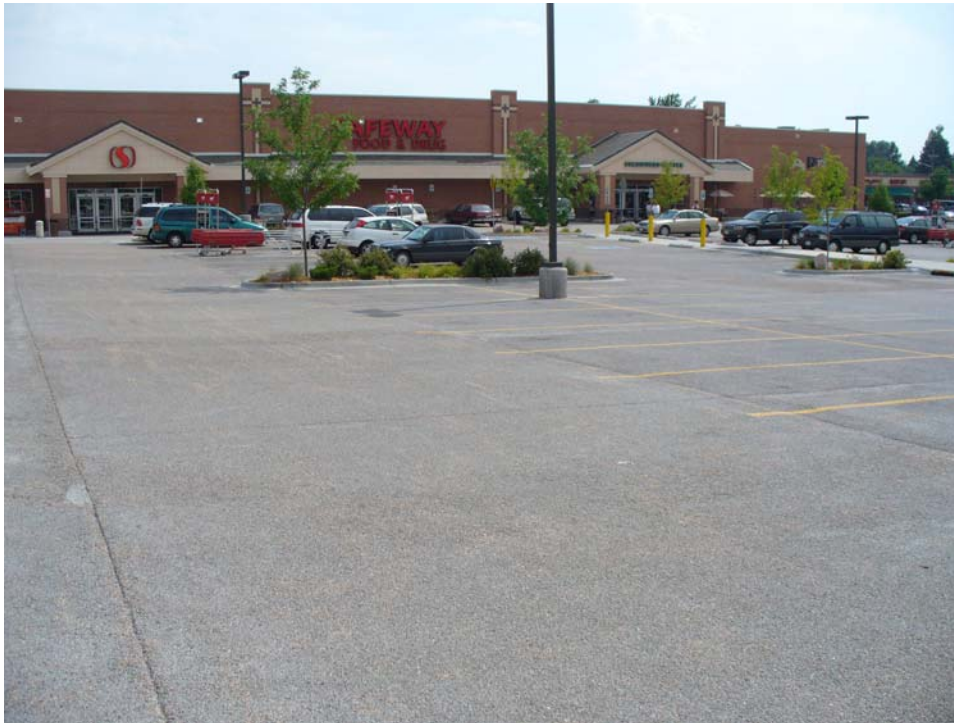
**Figure 30: Safeway Parking Lot, Denver, Colorado**

The Denver Safeway parking lot is shown in Figure 30. The entire parking lot is pervious concrete. There was no evidence of raveling, but some of the panels furthest away from the store entrance had cracks between the widely spaced joints. Surface drainage times of about 20 seconds were measured in a lightly used corner, with 35 – 40 seconds in the more heavily trafficked interior. One small section was clogged by an oil stain, with a drain time of 76 seconds. Overall, this parking lot provided good drainage.

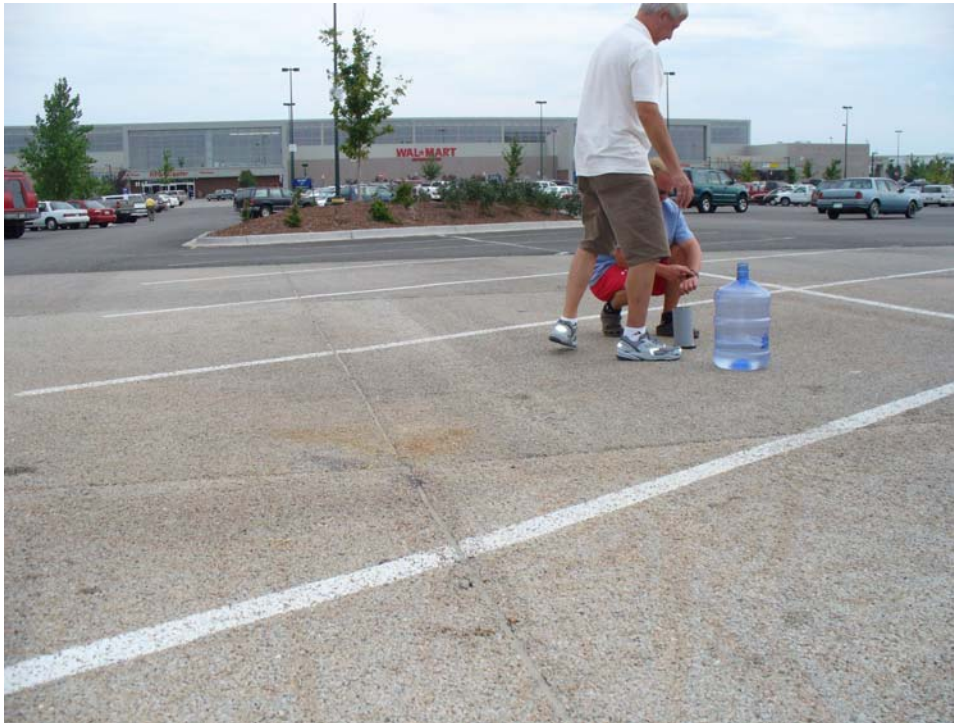
**Figure 31: Wal-Mart Parking Lot, east side of Denver, Colorado**

Pervious concrete was used for part of a parking lot at a Wal-Mart on the east side of Denver, shown in Figure 31. This parking lot used multiple paving materials, with the pervious concrete used for a strip some distance away from the store. There was no visual evidence of cracking or clogging. Drainage times measured in the parking stalls were 17, 19, 22, 23, and 34 seconds. One spot that had been clogged with coarse landscaping mulch had a drain time of 35 seconds, suggesting that this particular clog with large particles had not significantly decreased the infiltration capability of the parking lot. This parking lot also provided good drainage.

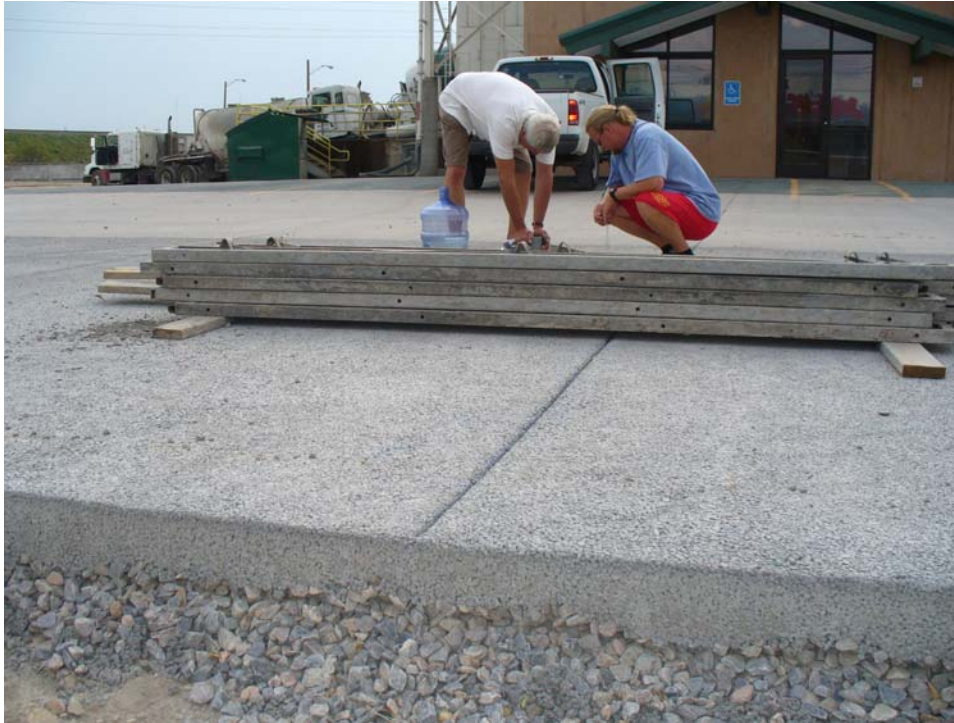
**Figure 32: Bestway Concrete parking lot, Denver, Colorado**

clogged with fines had a 25 second drain time. This installation, therefore, had very good drainage.
