# Portland Cement Pervious Concrete Pavement: Field Performance Investigation on Parking Lot and Roadway Pavements

## Final Report

December 1, 2007

Report to the RMC Research & Education  
Foundation

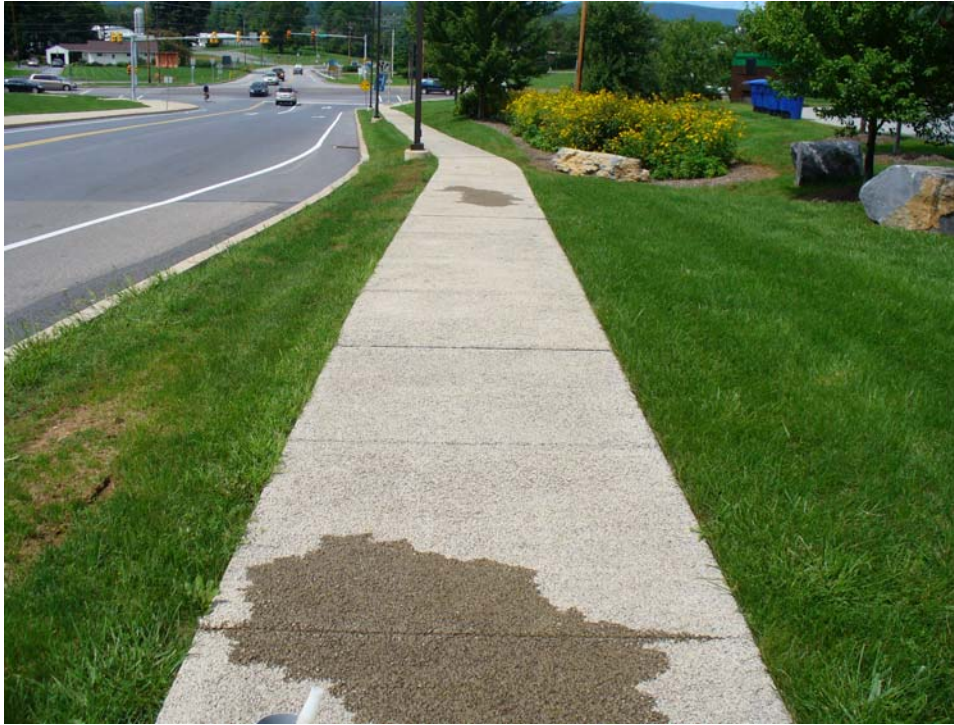
**Figure 33: Pennsylvania State University Visitors Center sidewalk**

The only Pennsylvania site visited was at the Pennsylvania State University Visitors Center sidewalk, State College. This site is shown in Figure 33. This was constructed in 1999 (NRMCA 2004). Therefore, this was the oldest installation that the researchers were able to investigate in person.

There is no evidence of cracking or raveling, so the sidewalk is in good structural condition with no evidence of freeze-thaw damage. However, the surface appeared to be closed off. This was confirmed by two drainage time tests which left large wet spots spread across the sidewalk, shown in Figure 33. Although the structural condition of the sidewalk is satisfactory, the infiltration capability appears to be very low. The Visitors Center also has a large permeable asphalt parking lot, which is also completely sealed off.

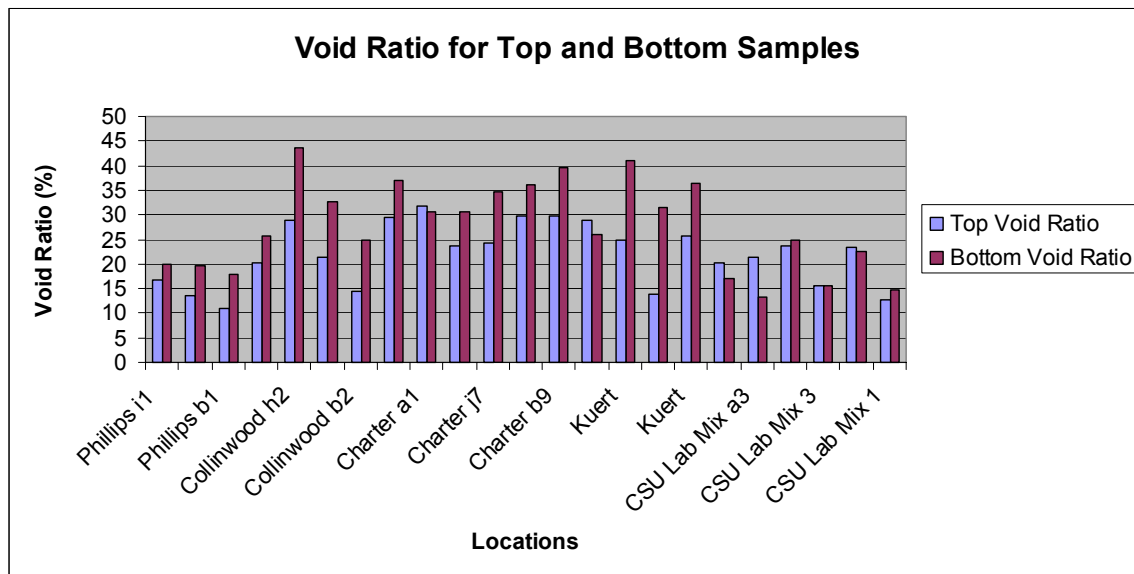
**Figure 37: Void Ratios for Top and Bottom Samples**

Haselbach and Freeman (2006) found that the void ratio at the top of a pervious concrete pavement was much lower than that at the bottom. The tests results reported in this section confirmed that finding.

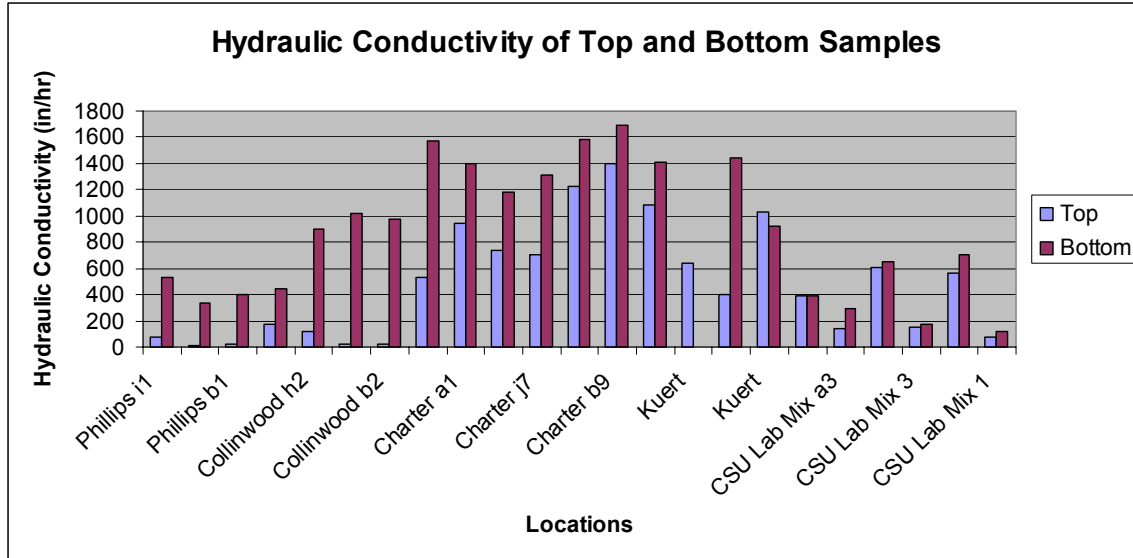
**Figure 38: Hydraulic conductivity for the Top and Bottom Samples**

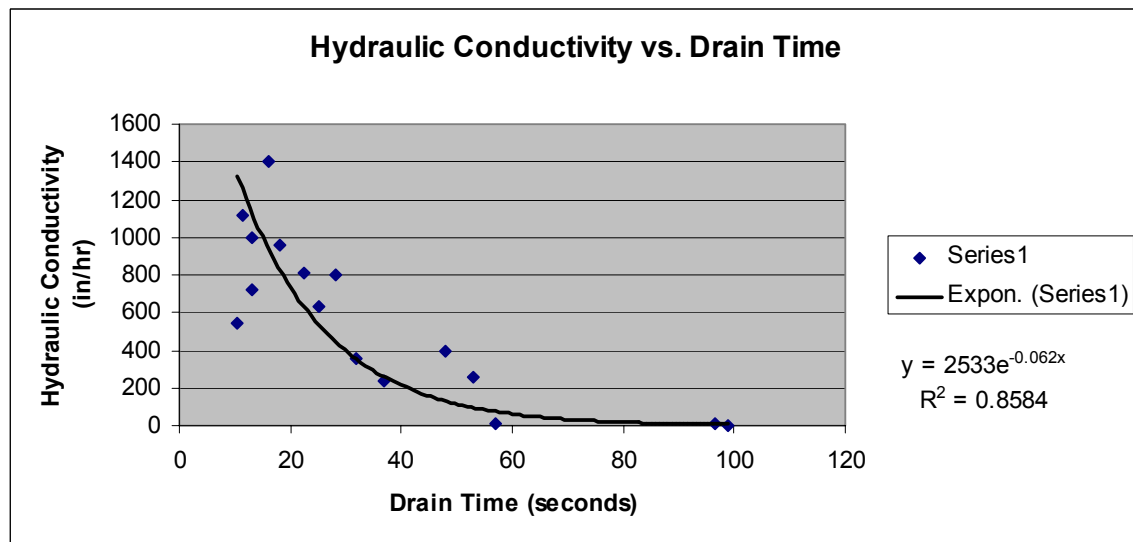
The field infiltration/ drain time test developed as part of this research will be more useful if it can be correlated to hydraulic conductivity. Laboratory and field values are shown in Table 23. The bold numbers represent drain time values that were measured in close proximity to the coring locations. At six locations, the drain time was measured prior to coring. The hydraulic conductivity and drain time values are plotted in Figure 39.

**Figure 39: Comparison between Hydraulic Conductivity and Drain Time Values**

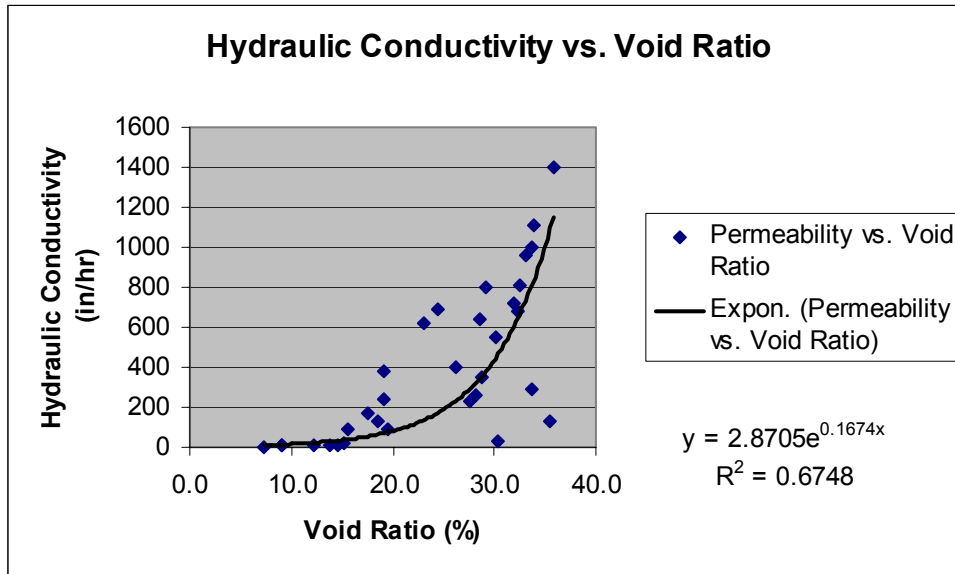
**Figure 40: Relationship between Hydraulic conductivity and Void Ratio**

As expected, hydraulic conductivity and void ratio are closely related, but there are some discrepancies. This is because the hydraulic conductivity depends on the interconnectivity of the voids, as well as the void ratio.

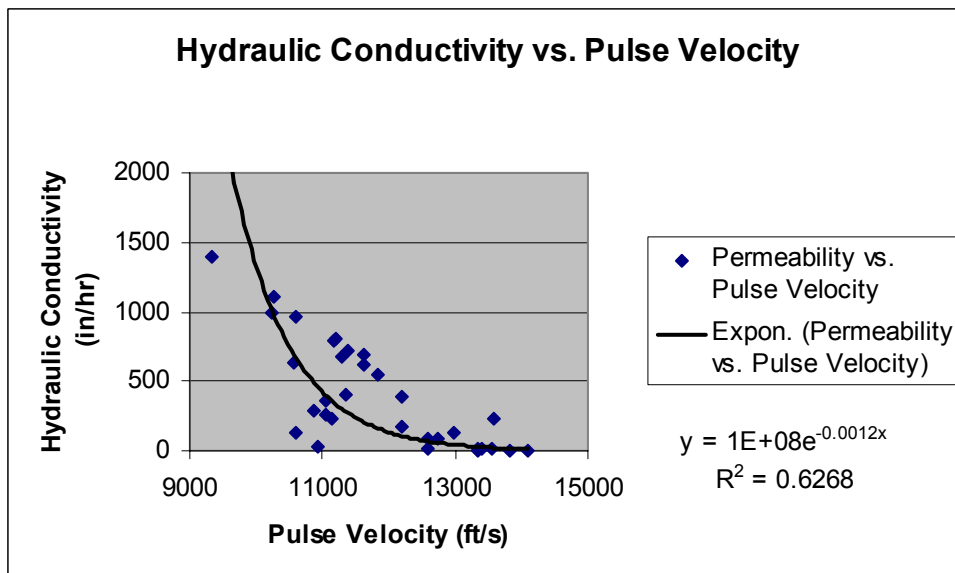
**Figure 41: Relationship between Hydraulic conductivity and Pulse Velocity**

The relationship between hydraulic conductivity and pulse velocity is the weakest of the six relationships developed. Pulse velocity is a more reliable indicator of strength and modulus of elasticity than of hydraulic conductivity. It can, however, provide a rough prediction.

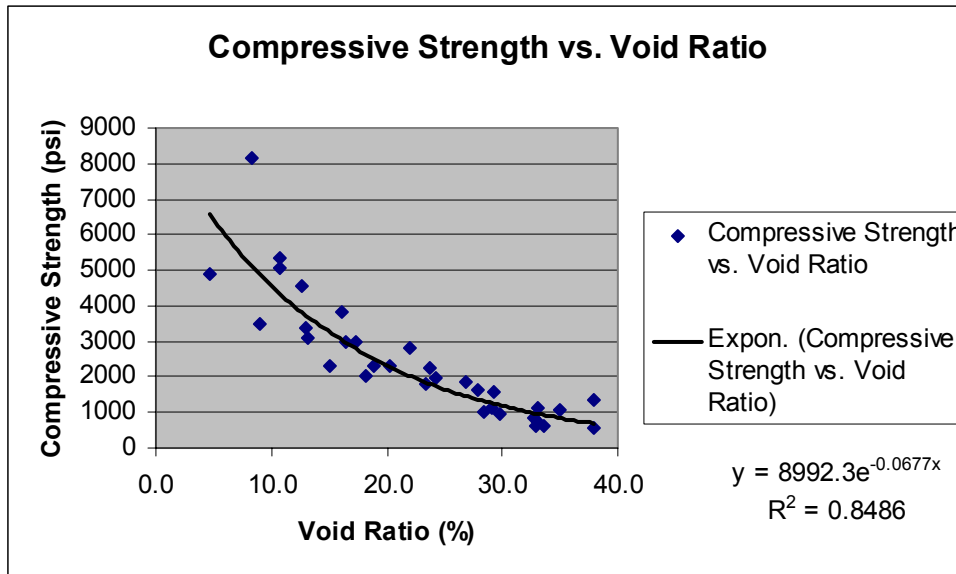
**Figure 42: Relationship between Compressive Strength and Void Ratio**

The relationship between compressive strength and void ratio has been documented by others, such as Schaefer et al. (2006), and is obviously strong.

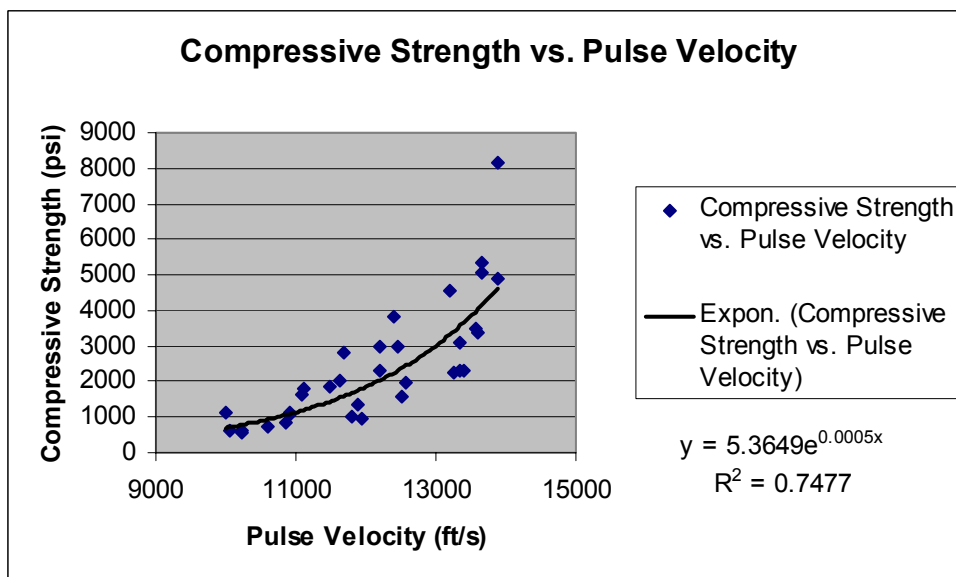
**Figure 43: Relationship between Compressive Strength and Pulse Velocity**

The relationship between pulse velocity and strength is also strong. The relationship would probably be improved without including one 8,000 psi outlier in the data. Therefore, UPV has potential for reliably predicting pervious concrete strength in the field.

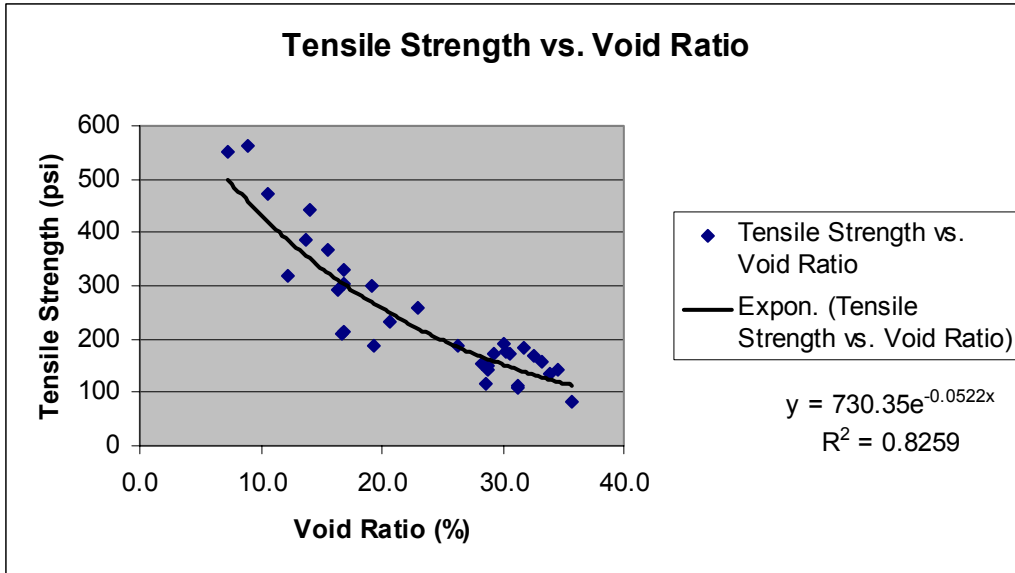
**Figure 44: Relationship between Tensile Strength and Void Ratio**

The relationship between void ratio and tensile strength is strong, as it is with compressive strength.

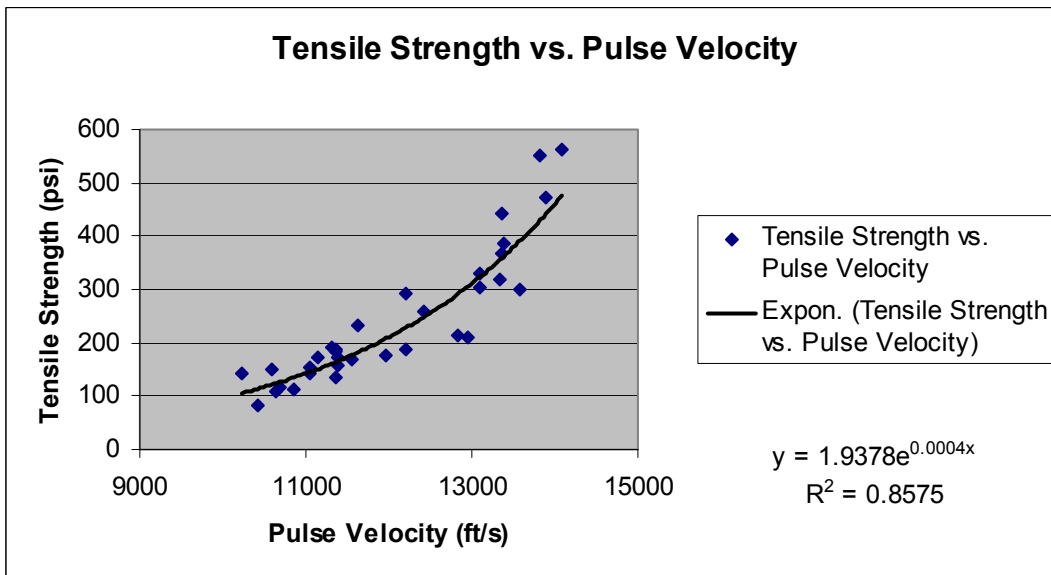
**Figure 45: Relationship between Tensile Strength and Pulse Velocity**
