NC STATE UNIVERSITY PERMEABLE PAVEMENT RESEARCH AND CHANGES TO THE STATE OF NC RUNOFF CREDIT SYSTEM

William F. Hunt, III and Eban Z. Bean

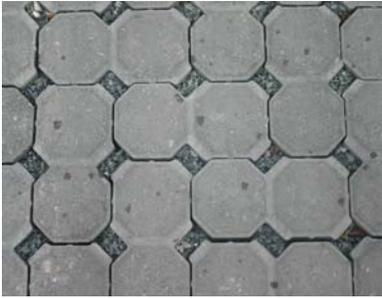
Figure 1a. PICP

Figures 1a, 1b, and 1c show three of the most common permeable pavements: concrete grid pavers (CGP), permeable interlocking concrete pavers (PICP), and permeable concrete (PC). CGP have both internal voids and voids between individual pavers. PICP are concrete pavers that when installed form

voids located at the corners and midpoints of pavers. PC is different from standard concrete in that fine aggregate has been removed from the mix, allowing interconnected void spaces to form during curing. Permeable pavements allow drainage through the existence or formation of these void spaces.

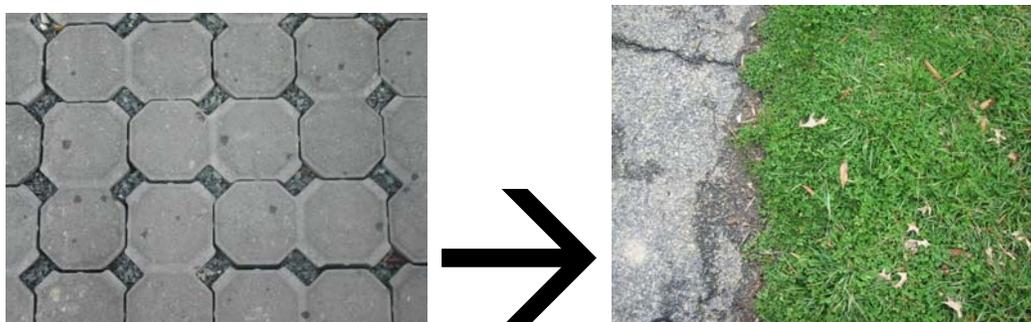
Figure 2. Ratio of grassed area to impervious pavement area hydrologically equivalent to permeable pavement.

For each hydrologic monitoring site, SCS Curve Numbers (CN's) were determined for each event that was greater than 5.0 cm. CN's are a measure of a surface's permeability. Higher numbers mean more runoff (USDA, 1986) Equivalent CN's were determined by back calculating through the SCS Curve Number equation. In addition, an equivalent ratio of grassed area (CN: 61) to pavement area (CN: 98) based on runoff depth for each event (> 5.0 cm) was calculated (Figure 2).
