Final Report

**Construction and Maintenance Assessment of Pervious Concrete Pavements**

Stormwater Management Academy  
University of Central Florida  
Orlando, FL 32816

January, 2007

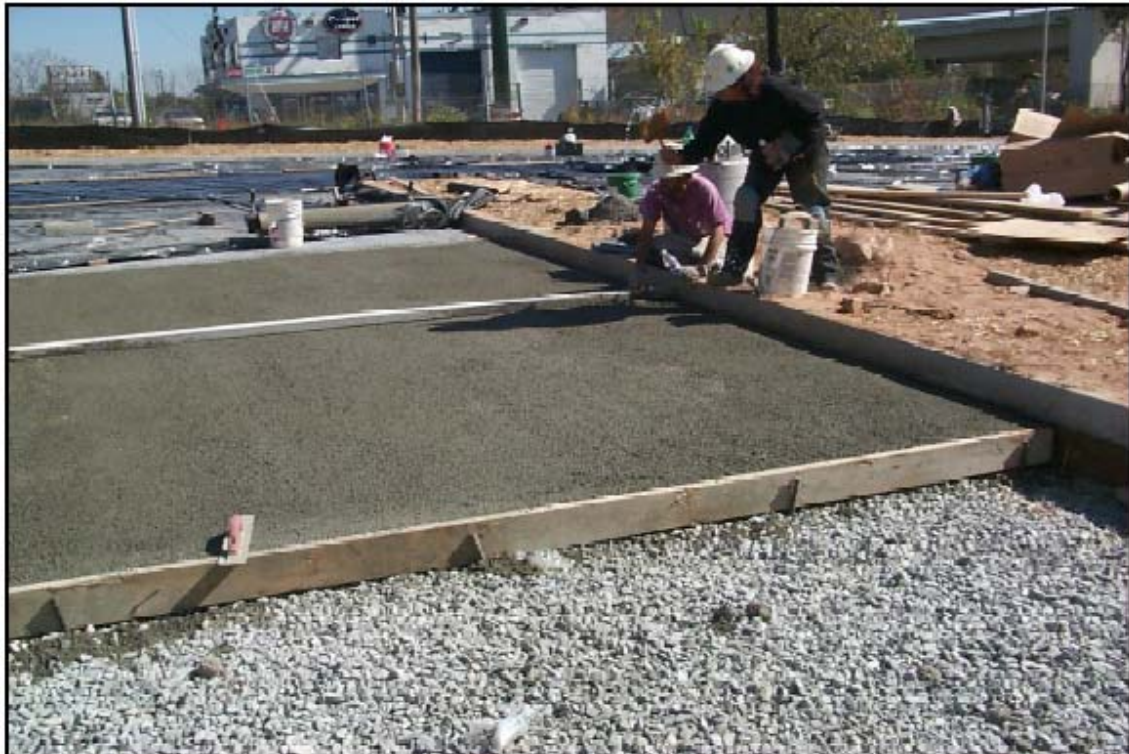
Figure 2: Typical Porous Concrete Installation

Porous concrete systems are typically used in low-traffic areas, such as, parking pads in parking lots, residential street parking lanes, recreational trails, golf cart and pedestrian paths and emergency vehicle and fire access lanes. Heavy vehicle traffic use must be limited to ensure raveling or structural failure does not occur in the porous pavement surface, which may fail under constant exposure to heavy vehicle traffic. The slopes of these installations should be flat or gentle to facilitate infiltration versus runoff and the EPA recommends a four-foot minimum clearance from the bottom of the system to the water table if infiltration is to be relied on to remove the stored water volume (EPA, 1999). Figure 2 shows a typical porous concrete installation.

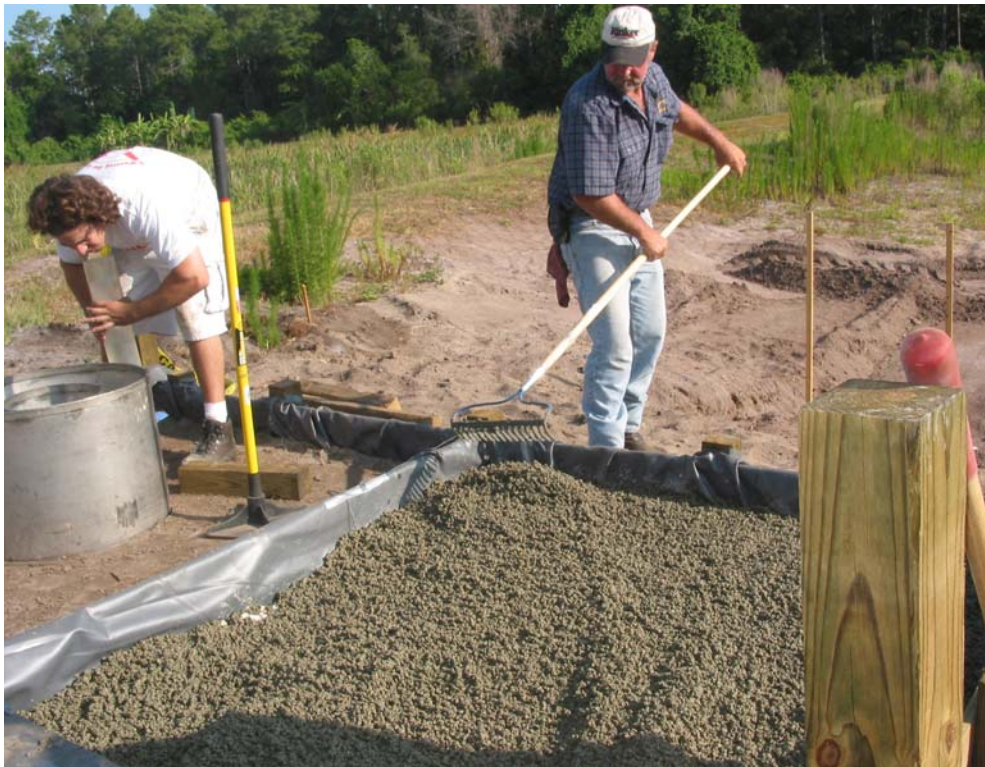
Figure 3: Stormwater Academy Porous Concrete Test Cell Installation

per hour as determined by application of a double-ring infiltrometers test (ASTM D 3385-94). One cell contains a five-inch deep reservoir of  $\frac{3}{8}$  to  $\frac{1}{2}$  inch coarse aggregate, and both cells have a five- inch thick pervious concrete slab. Depicted in Figure 3 is the installation of the pervious concrete in the test cells as well as a double-ring infiltrometer test being performed on the compacted subsoil.

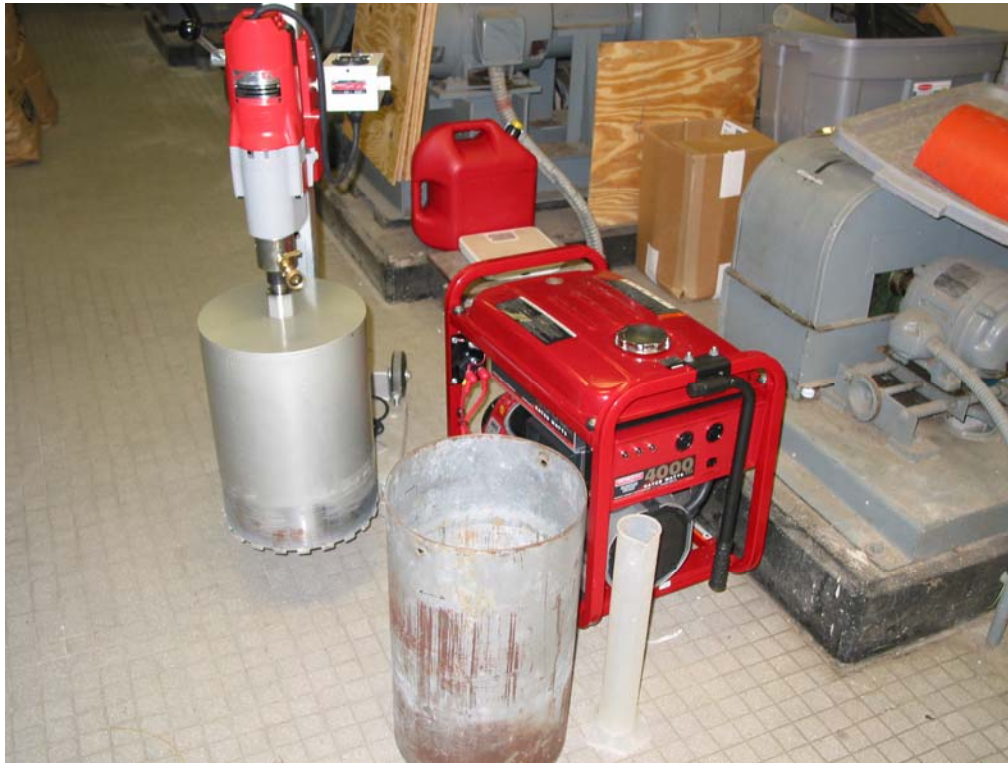
Figure 7: Coring Rig, Core Bit, Single-Ring Infiltrometer, and Generator

1. The pervious concrete surface is cored in three evenly spaced locations utilizing a 12 inch outside diameter, diamond tipped concrete core bit. The drilling process takes between 10 and 30 minutes per concrete core depending on the type of aggregate used in the concrete mix and depth of the concrete slab. The coring rig and the core bit are shown in Figure 7.

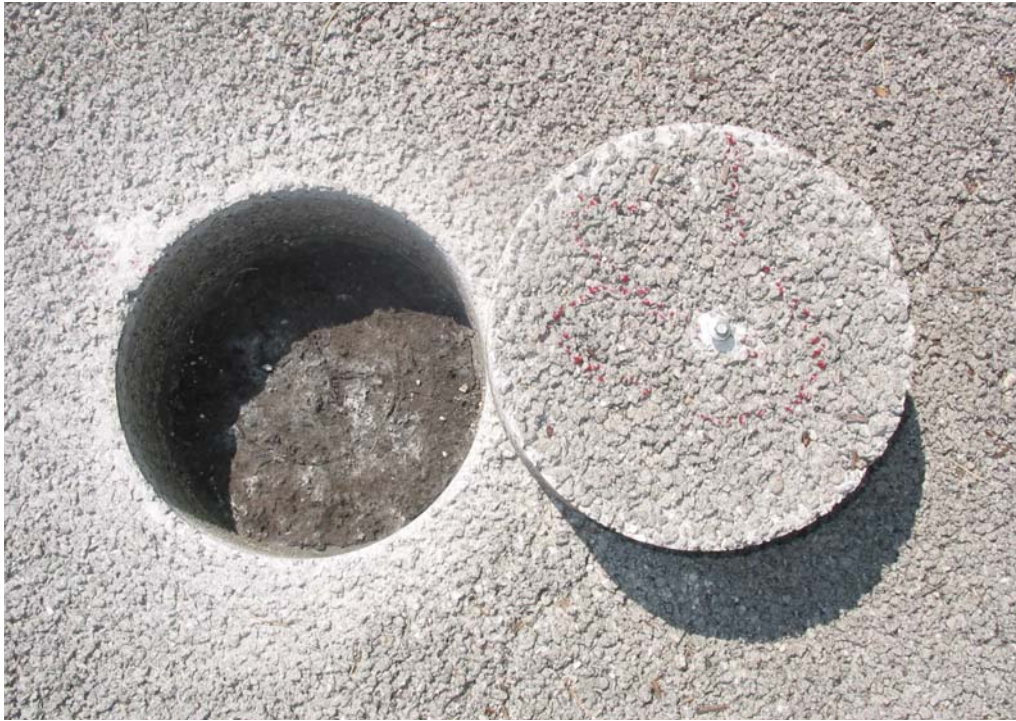
Figure 8: Pervious Concrete Pavement Core

The core samples are left in place after drilling for in-situ infiltration testing. When necessary, the cores were extracted and grinded along the sides to remove irregularities formed during the coring process to allow the single-ring infiltrometer to fit around the core. A four-inch angle grinder with a masonry disk was utilized for this task. Figure 8 shows the 12 inch core placed next to the location it was removed from in the pavement. It is clear that the pavement system at this site does not have a drainage layer of gravel. This configuration is typical for pavements on soils with high permeability values.

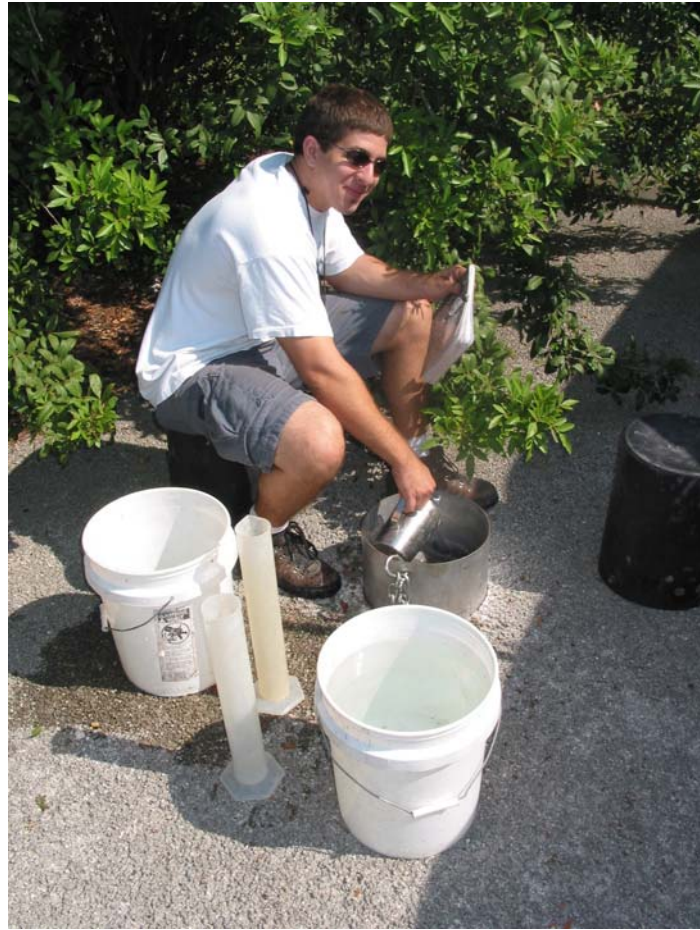
Figure 9: Pervious Concrete Pavement Core Test

2. Once the single-ring infiltrometer can pass into the cut made by the coring rig, the infiltrometer is embedded into the subsoil by applying a downward force. The infiltrometer is typically installed using a hand-tamper making sure to mark the infiltrometer before embedment to ensure the infiltrometer is installed to the proper depth.
3. After the single-ring infiltrometer is embedded to the proper depth, a bead of plumber's putty is placed around the inside circumference of the infiltrometer to prevent side-wall leakage.
4. Infiltration rates of the three cored locations are measured using the embedded Single-ring Infiltrometer Test as discussed in the previous section. Figure 9 shows a test in progress with the infiltrometer in the embedded state.

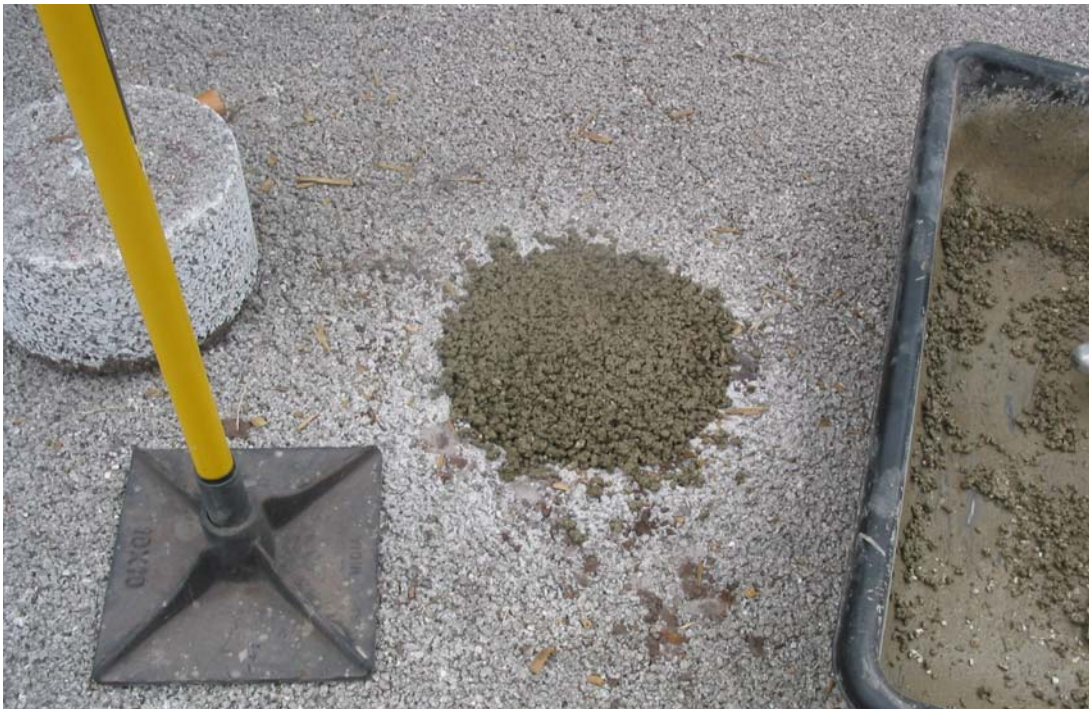
Figure 11: Repair of Concrete Core Area

9. Water table depths are recorded for use in modeling studies planned for the pervious concrete system.
10. The subsoil shall be replaced and the pervious concrete is repaired using the original specifications at the locations where it was cored. An example of this patching is depicted in Figure 11.

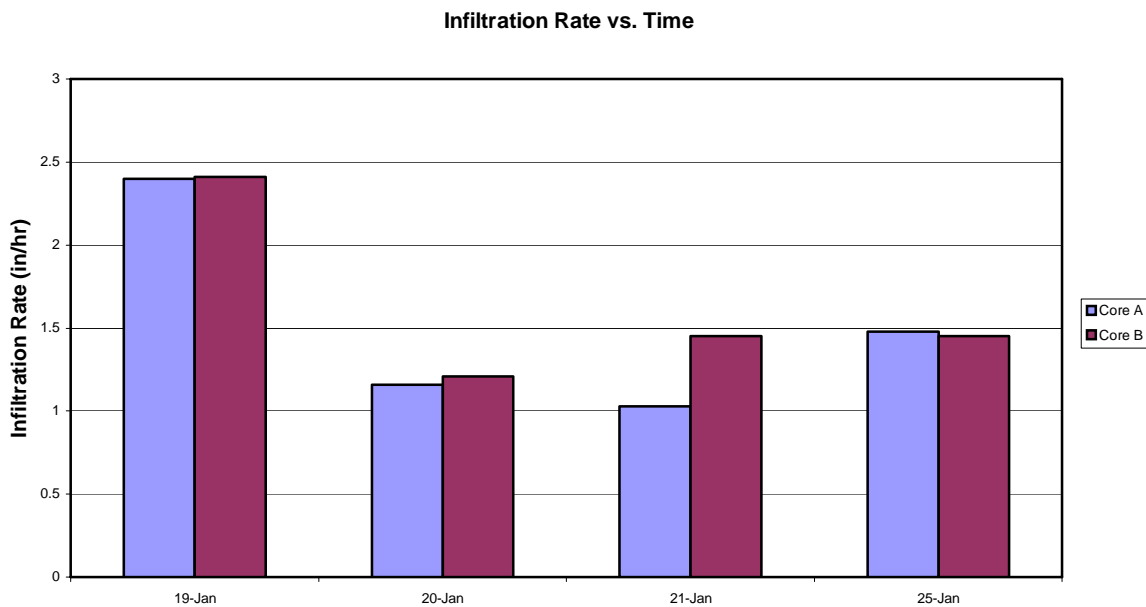
Figure 14: Visual Summary of Pervious Concrete System Infiltration Rates

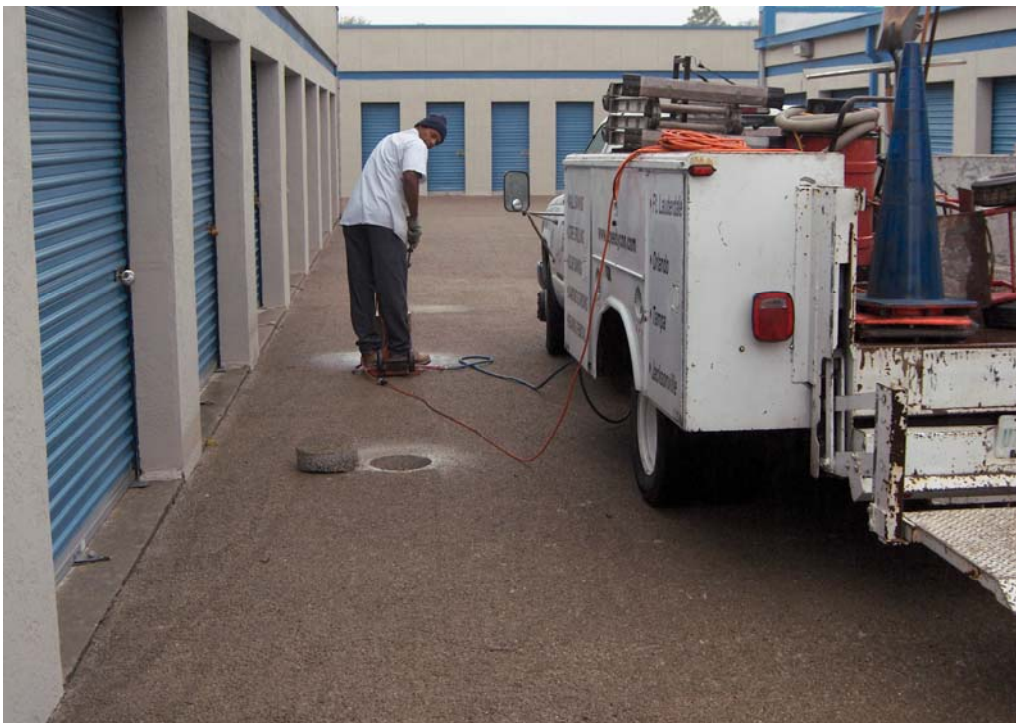
Figure 16: Sun Ray Store-Away Pervious Pavement at Core Locations 1, 2 & 3

infiltration rates measured in the laboratory that ranged from a high of 627 to a low of 3 in/hr. Instances where the system infiltration rates are higher than the individual core infiltration rates measured in the lab is due to infiltration along the sidewall of the cores that occurred in the field but was restricted in the lab producing false high infiltration rates in the field. The cores performed in the area of cores 1, 2 and 3 exhibited higher infiltration rates than other areas. This result was anticipated as the pervious concrete surface in that area was after visual determination in better condition; this area is shown in Figure 16.

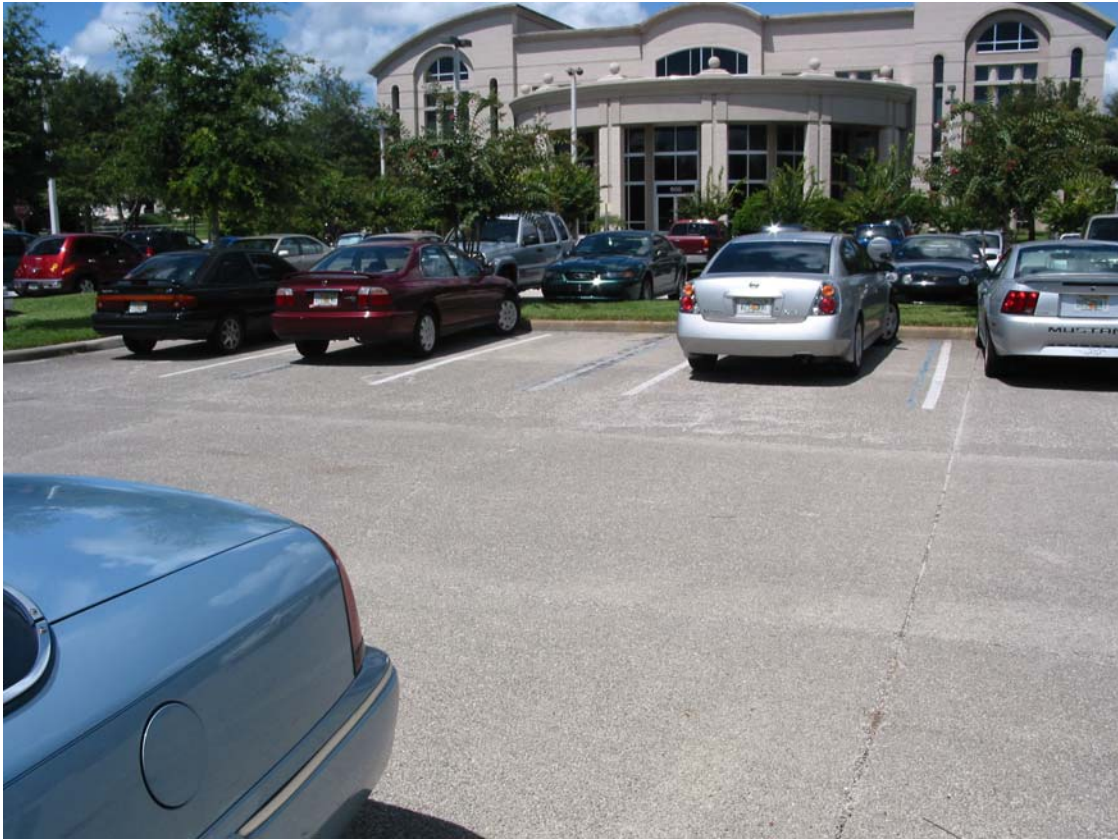
Figure 18: Strang Communication Office Parking Lot

This pervious parking lot exhibited minimal damage to the surface, although, significant raveling has taken place in one location on the site. Raveling is the deterioration of the concrete due to repeated loads over time on an area. The nine spaces located in the northwest area of the pervious concrete are raveling at the entrance to each stall. Also, a small amount of raveling at the entrance to the parking row on the west was also noted. Algae and leaf debris staining are also present over a majority of the pervious concrete parking lot. Figure 17 shows the location of the raveling and algae in this parking area. Depicted in Figure 18 is a picture of this site.

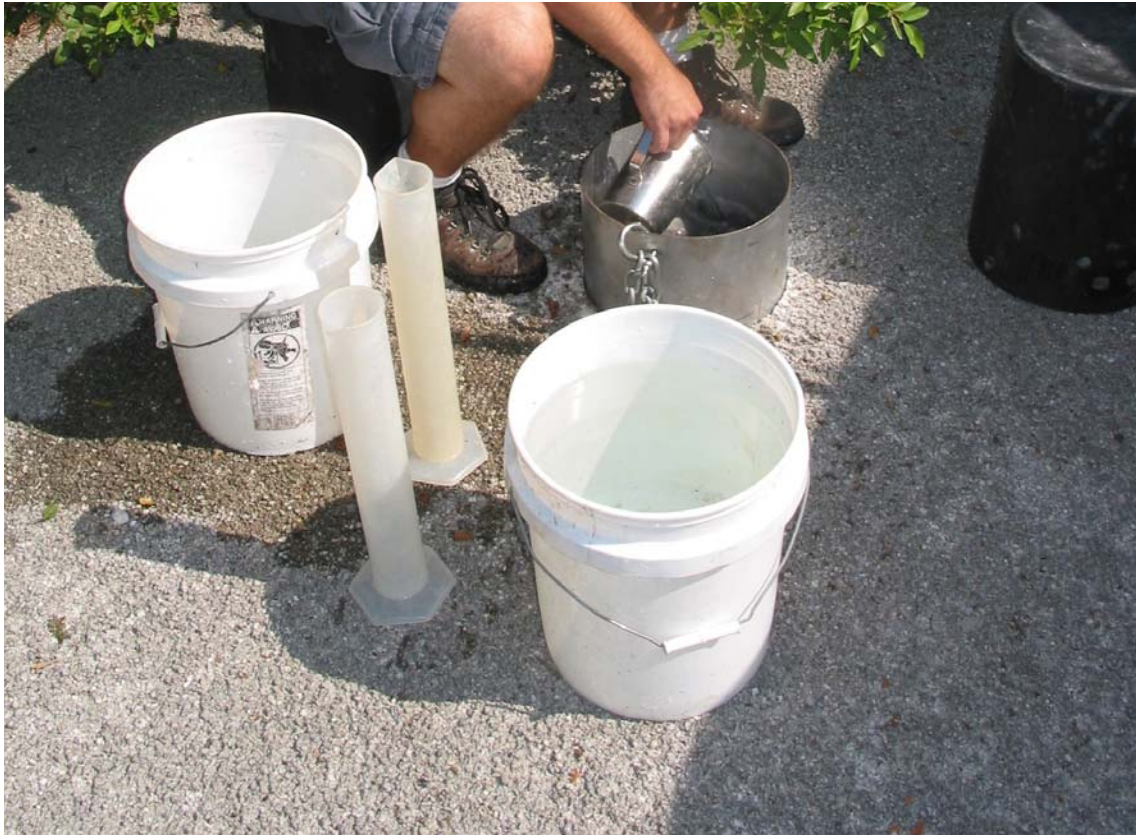
Figure 20: Murphy Veterinarian Clinic Core Test

The subsoil characteristic to the pervious concrete parking lot at the Murphy Veterinarian Clinic exhibited infiltration rates typical of type A hydrologic soils. Infiltration rates of the subsoil ranged from 15.78 to 27.21 in/hr. in the field and 3.41 to 7.91 in/hr. in the laboratory permeability tests. The difference in infiltration rate is believed to be due to the higher level of compaction of the laboratory soil samples. Field system infiltration rates were not measured due to the lack of access to a power source at the field site, which limited the ability to grind the sides of the pervious concrete cores to allow the single-ring infiltrometer to fit around the core. Core infiltration rates exhibited infiltration rates measured in the laboratory that ranged from 2.3 to 24 in/hr. This result indicates that the pervious concrete surface is acting as the limiting factor at this pervious concrete installation. Figure 20 depicts a subsoil infiltration test being performed at the field site.

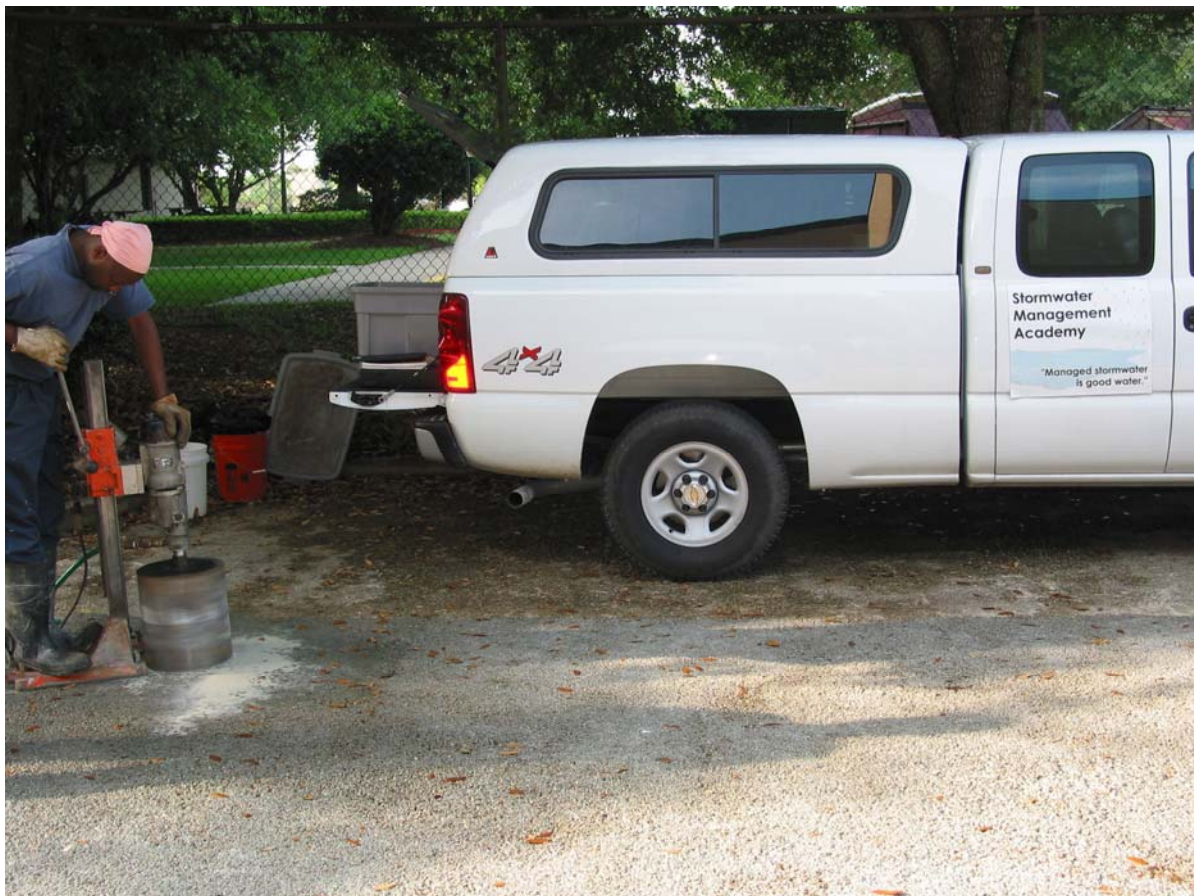
Figure 22: FDEP Parking Lot Core Test

ranged from 0 to 5.2 in/hr. The cores performed in the area of cores 4, 5 and 6 exhibited higher infiltration rates than other areas. This result was anticipated as the condition of the pervious concrete surface in the other areas was compromised due to poor construction practices. Higher than typical unit weights are also indicative of poor construction practices. Low infiltration rates of the subsoil in the areas of Cores 4 through 6 was due to a layer of poorly draining, orange clay encountered directly beneath the pervious concrete. Figure 22 depicts the coring operation performed at this site.

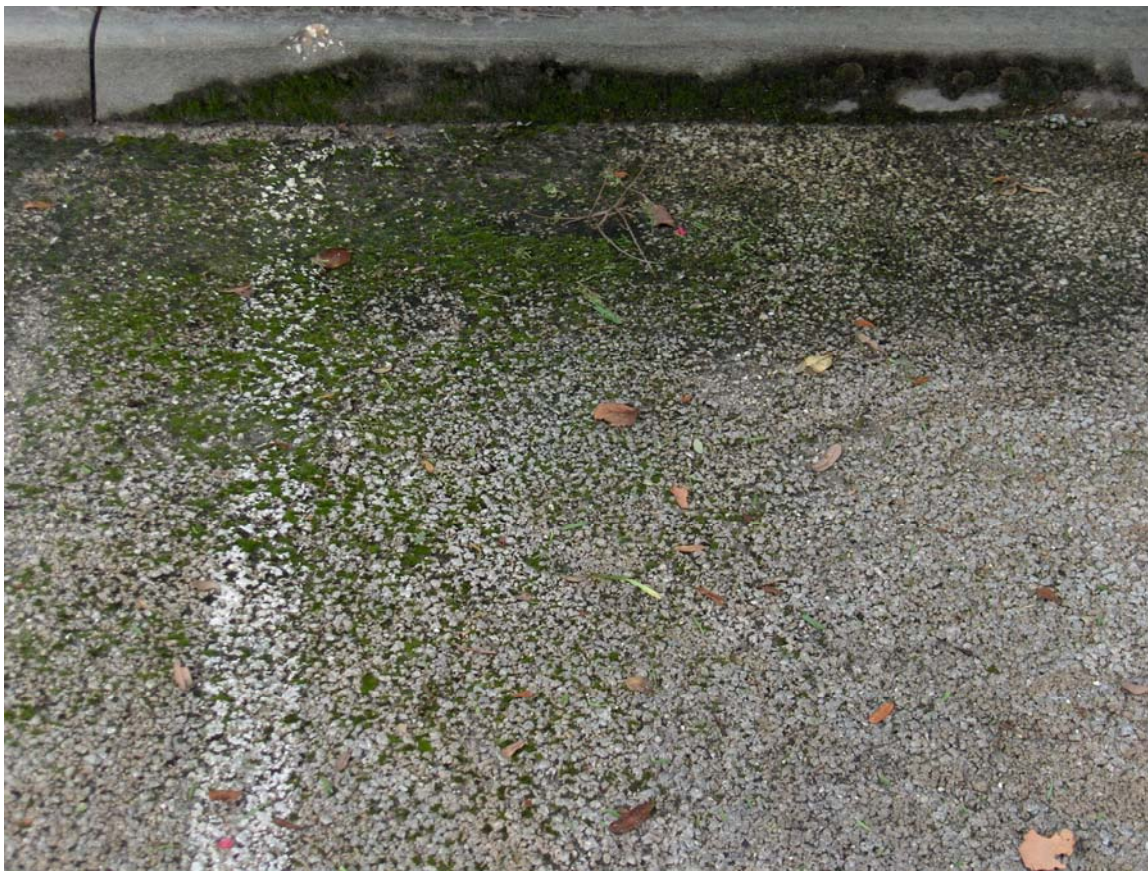
Figure 24: FCP&A Parking Lot

ranged from 8.54 to 9.07 in/hr. in the field and laboratory permeability tests confirmed these rates. Core infiltration rates measured in the laboratory ranged from 1.8 to 5.8 in/hr. Field system infiltration rates were not measured due to the lack of access to a power source on the site, which limited the ability to grind the sides of the pervious concrete cores to allow the single-ring infiltrometer to fit around the core. This result indicates that the pervious concrete surface is acting as the limiting factor at this pervious concrete installation. A photograph depicting the condition of the pervious concrete in this area is shown in Figure 24.

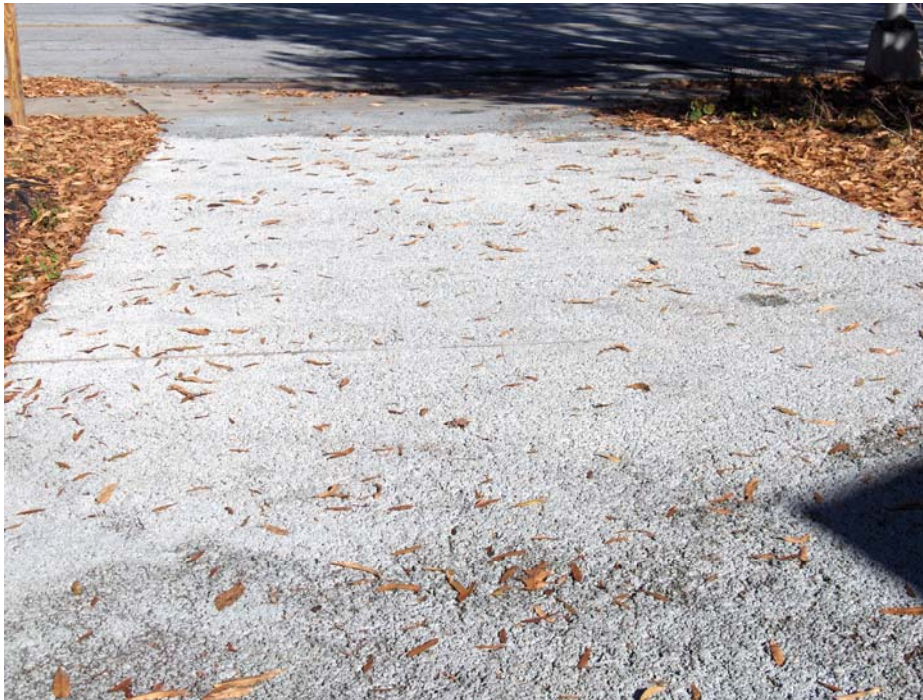
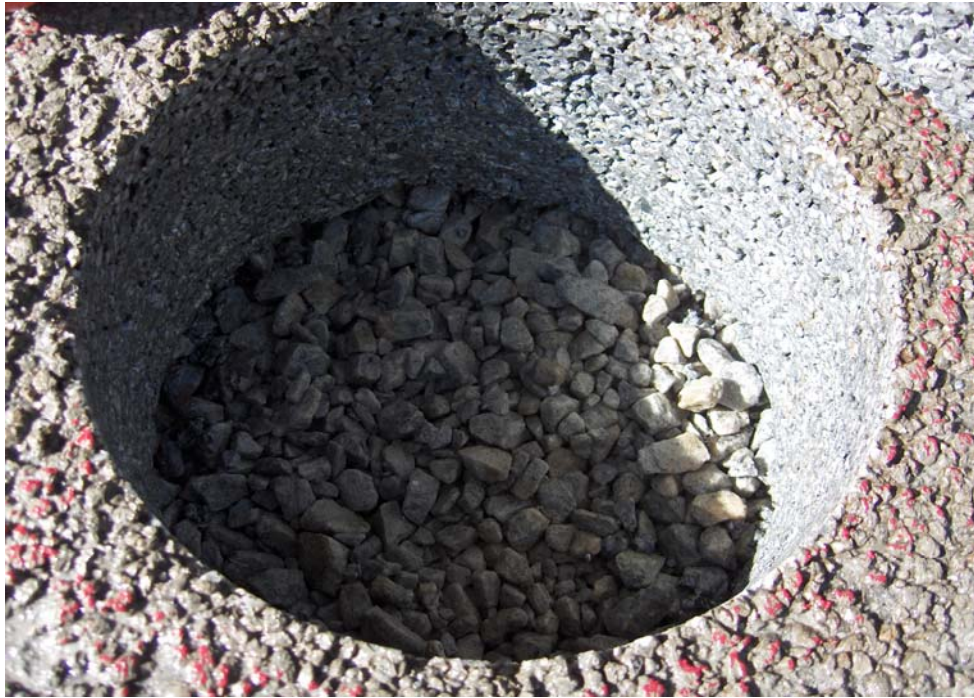
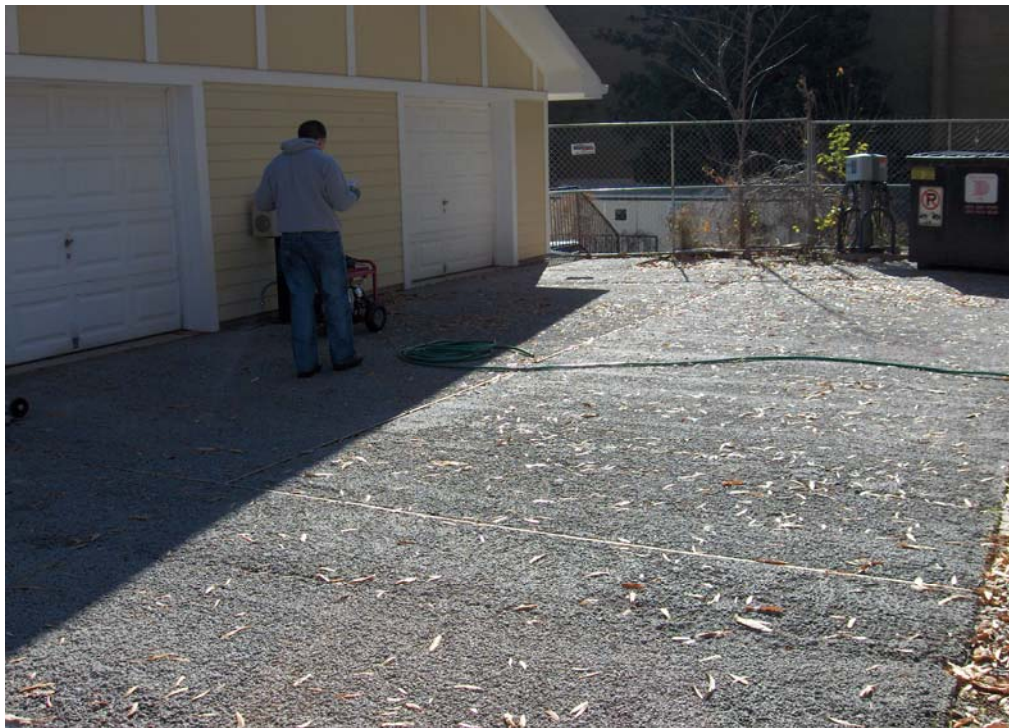
Figure 26: Southface Institute Parking Lot

Figure 27: Southface Institute Gravel Subbase

Figure 28: Southface Institute Parking Lot

188 in/hr. This wide range of infiltration rates can be contributed to varying surficial pore sizes and unit weights in pervious concrete due to poor construction techniques. Field system infiltration rates were not measured due to the presence of a gravel reservoir, which the single-ring infiltrometer is unable to penetrate. These results indicate that the subsoil is acting as the limiting factor at this pervious concrete installation, however a gravel reservoir has added storage to the site to allow a longer recharge time. Laboratory tests indicate the gravel reservoir has a porosity of approximately 0.32 or a storage capacity of approximately 2 inches of water. Photographs depicting the condition of the pervious concrete in this area are shown in Figures 26, 27 and 28.

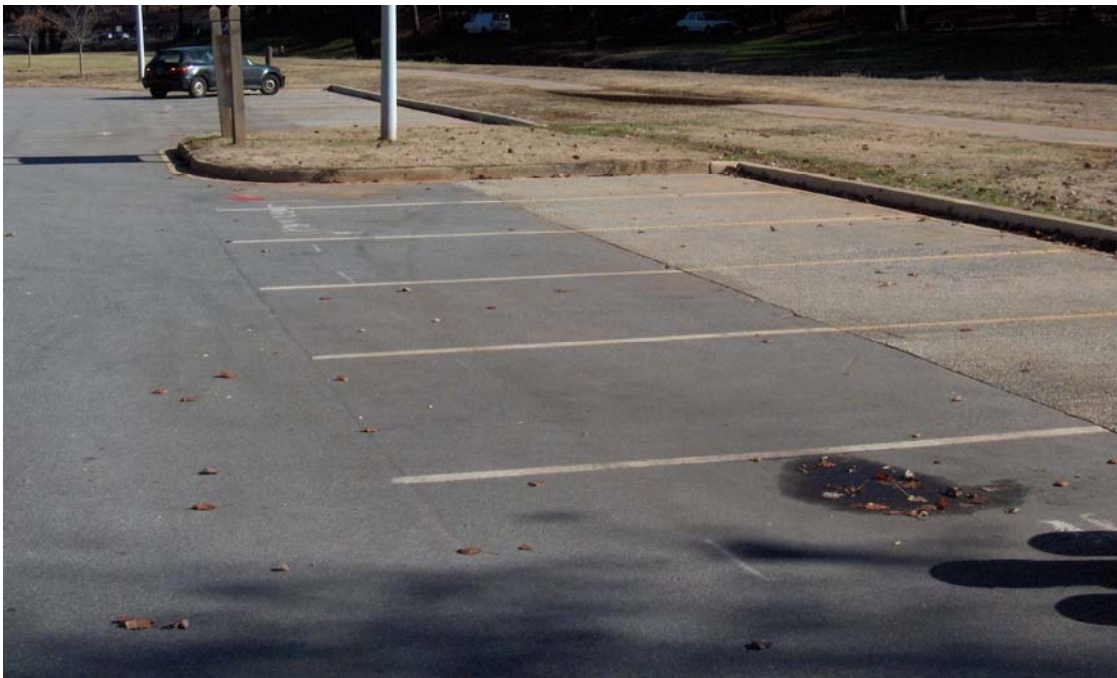
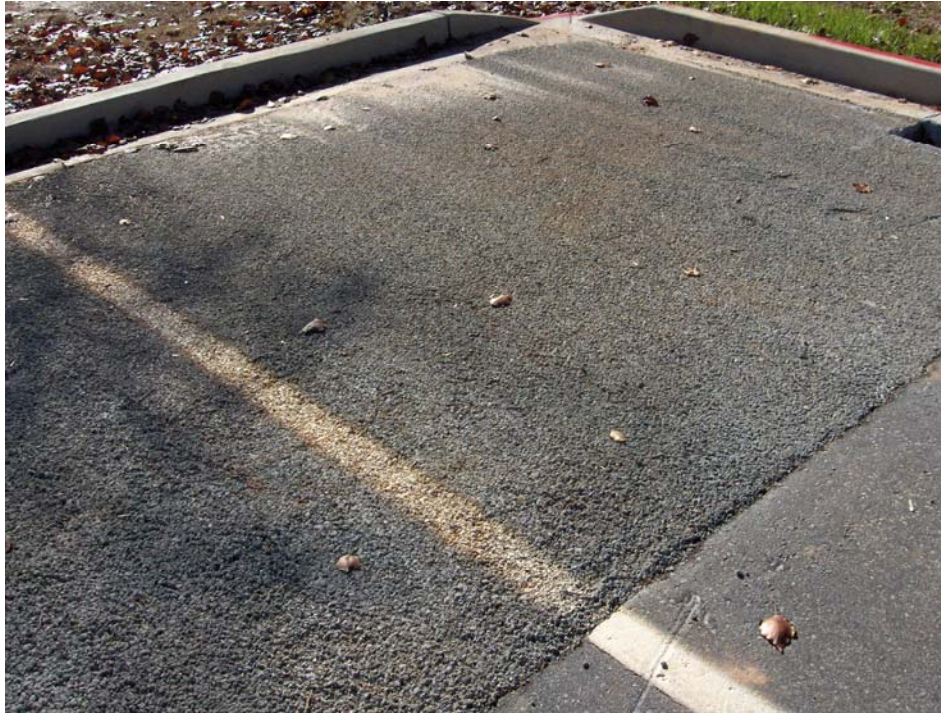
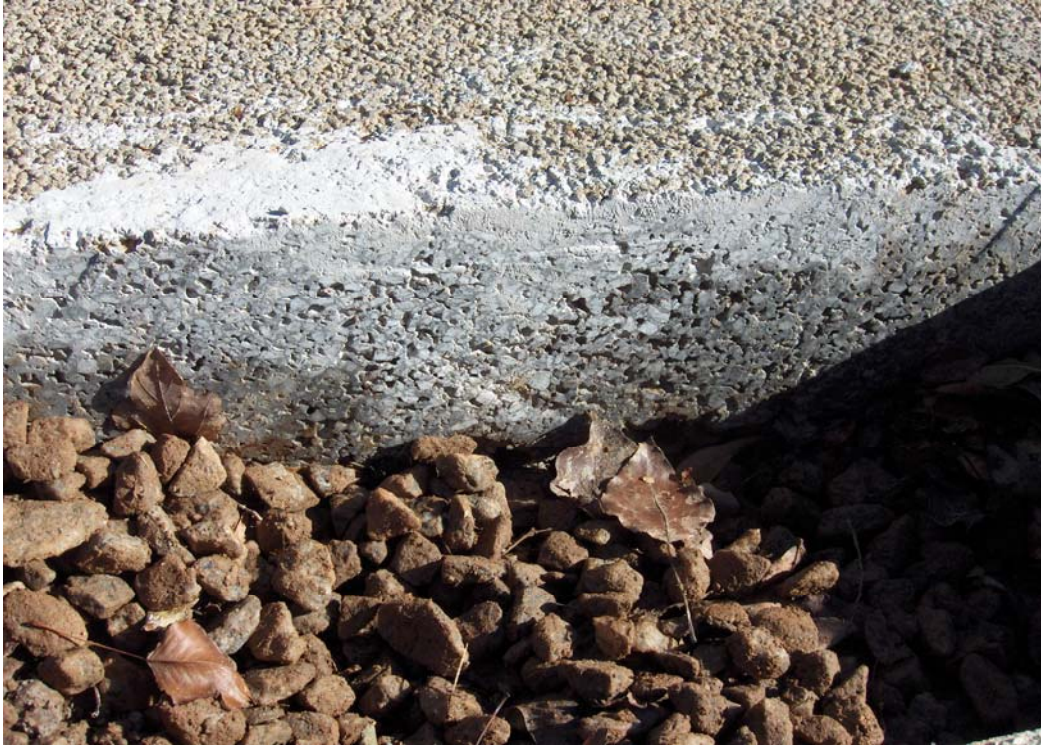
Figure 30: Cleveland Park Parking Lot

Figure 31: Cleveland Park Parking Lot Pavement

Figure 32: Cleveland Park Parking Lot Reservoir

zero that was measured was due to a lack of voids present in the concrete due to poor construction techniques as verified by the comparatively high unit weight of the core. Field system infiltration rates were not measured due to the presence of a gravel reservoir, which the single-ring infiltrometer is unable to penetrate. These results indicate that the subsoil is acting as the limiting factor at this pervious concrete installation, however, a gravel reservoir has added storage to the site to allow a longer recharge time. Laboratory tests indicate the gravel reservoir has a porosity of approximately 0.32 or a storage capacity of approximately 2 inches of water. Photographs depicting the condition of the pervious concrete in this area are shown in Figures 30, 31 and 32.

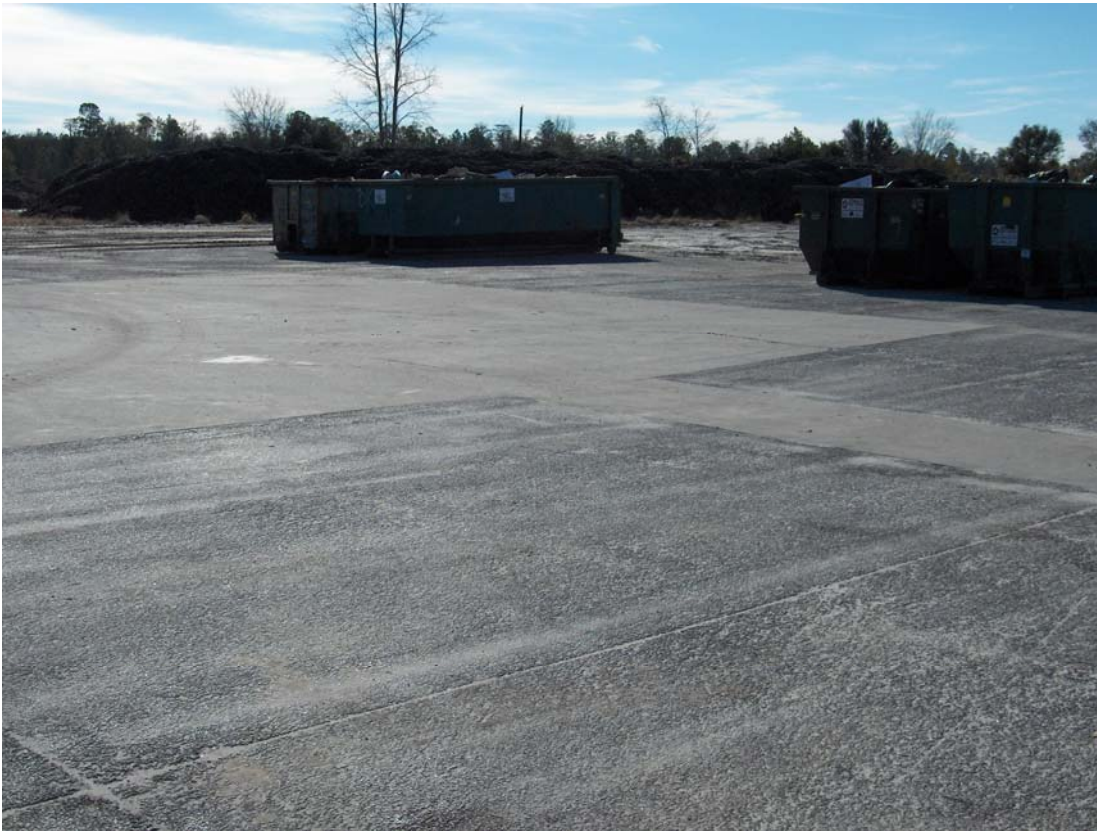
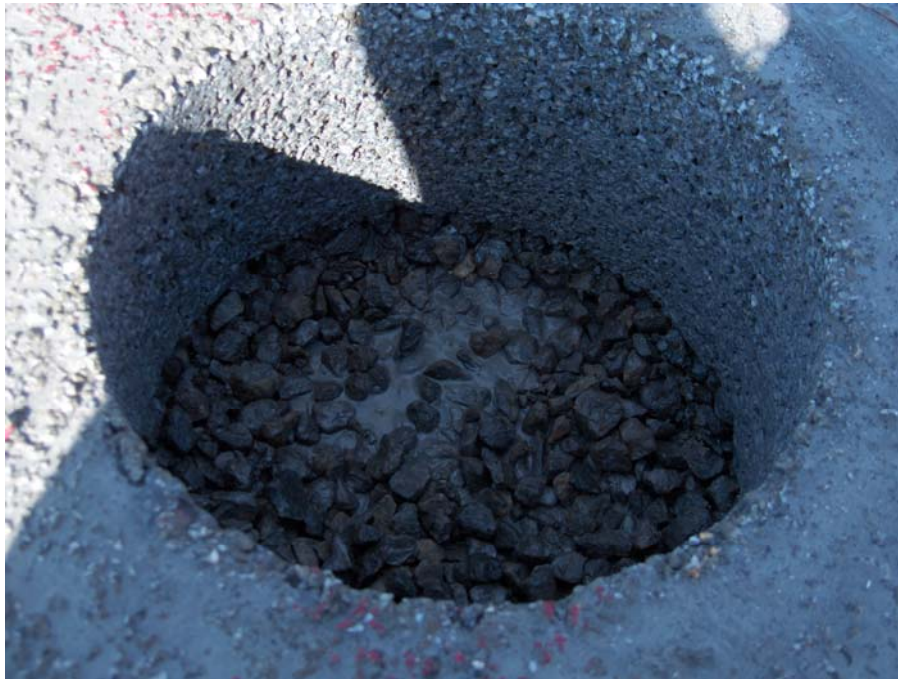
Figure 34: Effingham County Landfill

Figure 35: Effingham County Landfill Pervious Pavement

Figure 36: Effingham County Landfill Reservoir

be attributed to varying surficial pore sizes in the pervious concrete due to poor construction techniques. Field system infiltration rates were not measured due to the presence of a gravel reservoir, which the single-ring infiltrometer is unable to penetrate. These results indicate that the subsoil is acting as the limiting factor at this pervious concrete installation, however, a gravel reservoir has added storage to the site to allow a longer recharge time. Laboratory tests indicate the gravel reservoir has a porosity of approximately 0.32 or a storage capacity of approximately 2 inches of water. Photographs depicting the condition of the pervious concrete in this area are shown in Figures 34, 35 and 36.

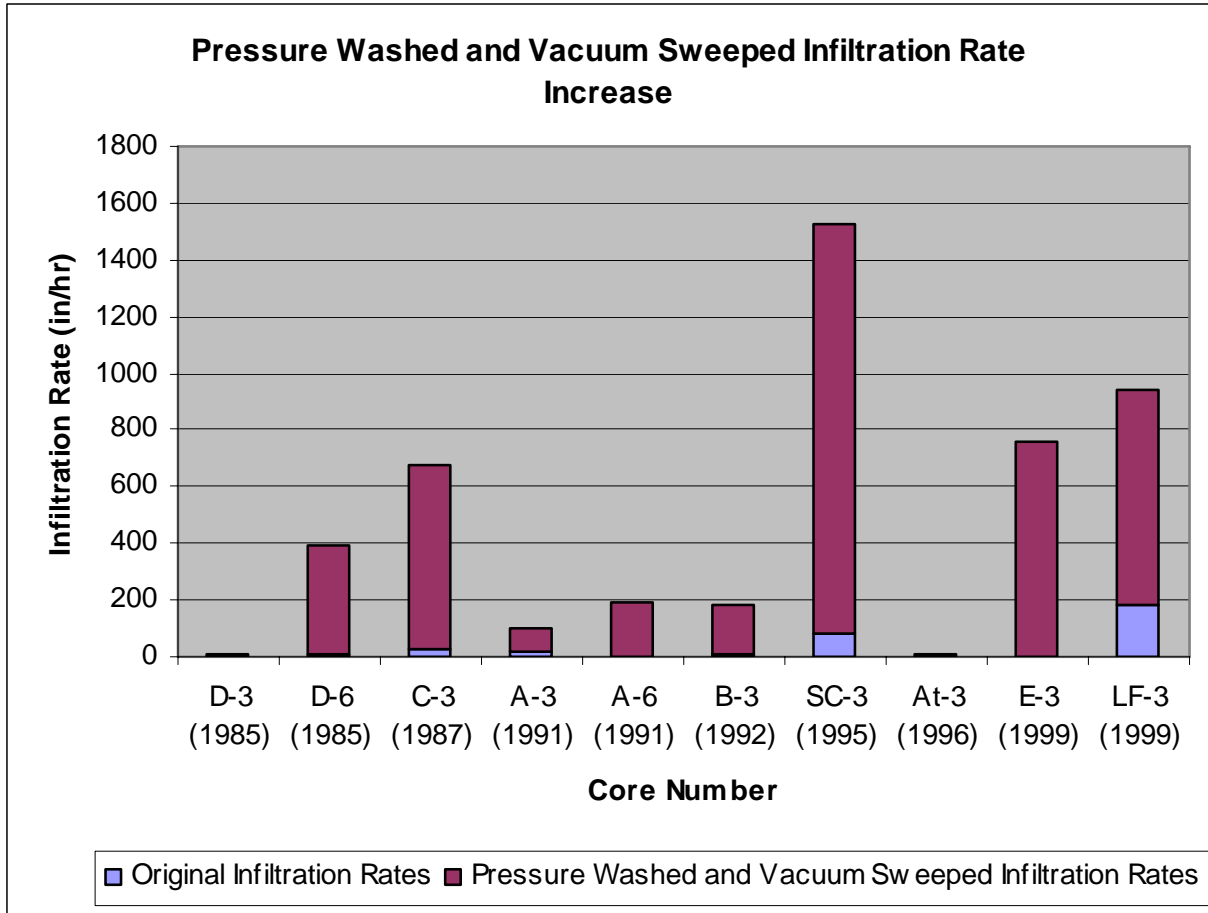
Figure 37: Comparison of Original and Pressure Washed and Vacuum Swept Infiltration Rates

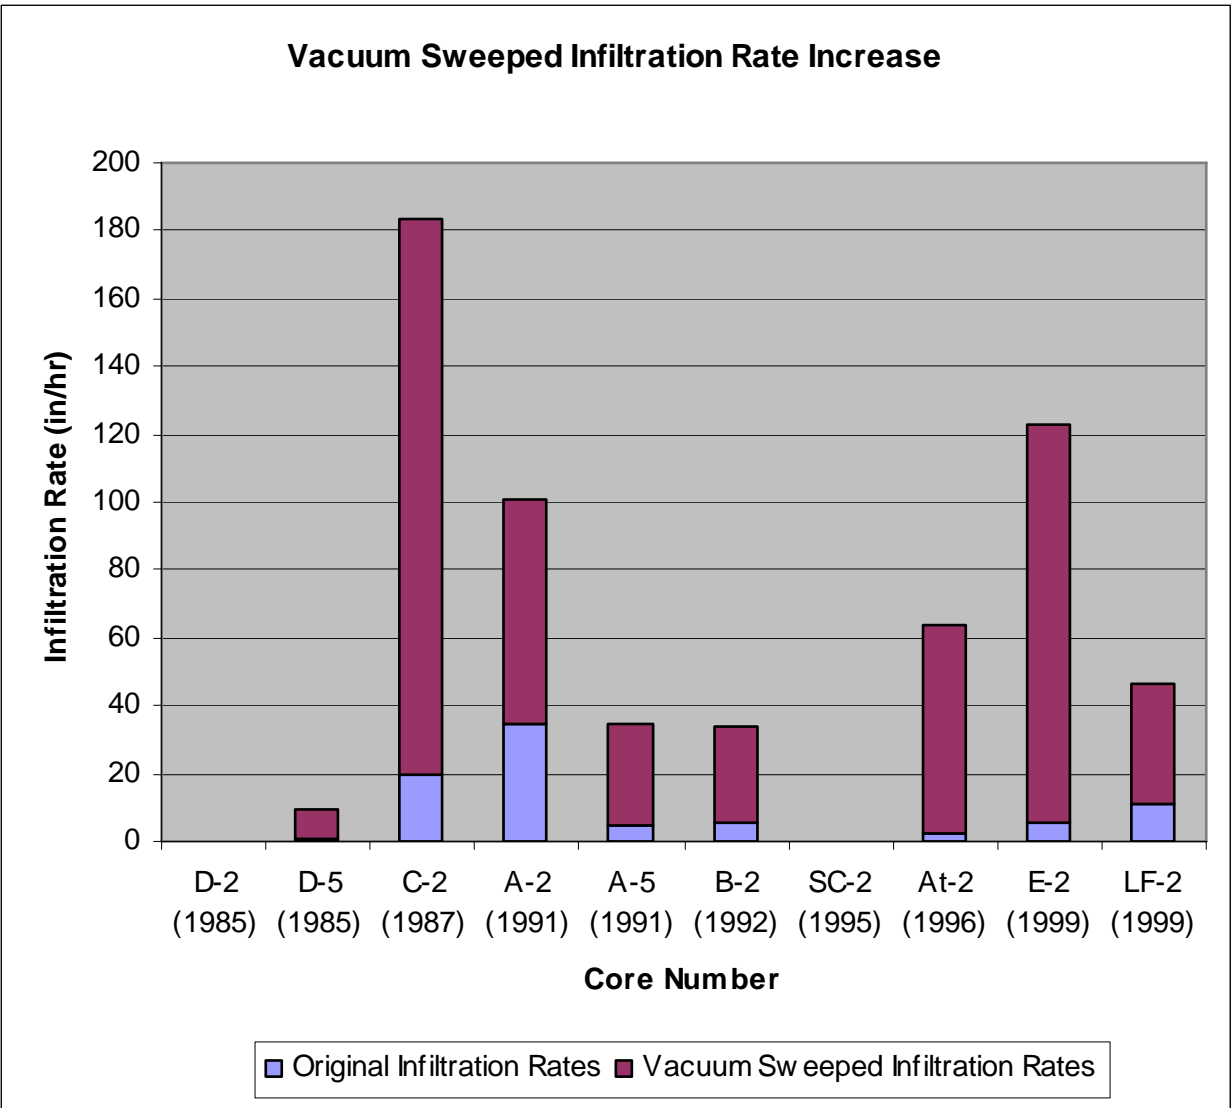
Figure 38: Comparison of original and Vacuum Swept Infiltration Rates

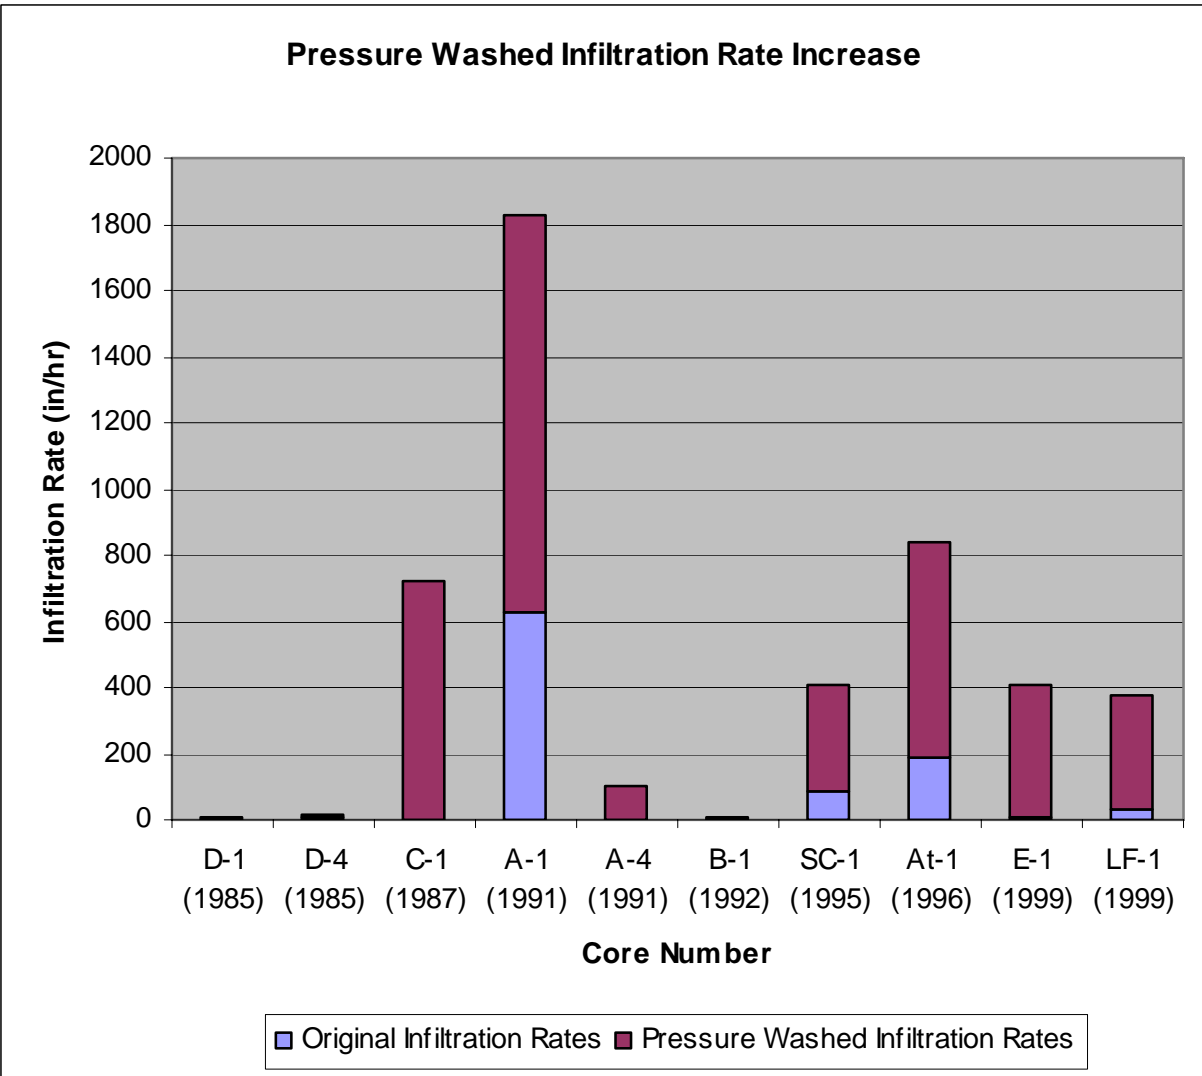
Figure 39: Comparison of Original and Pressure Washed Infiltration Rates

The pervious pavement at sites D2 and SC2 were not installed properly and exhibited the density and zero infiltration characteristics common to regular concrete.

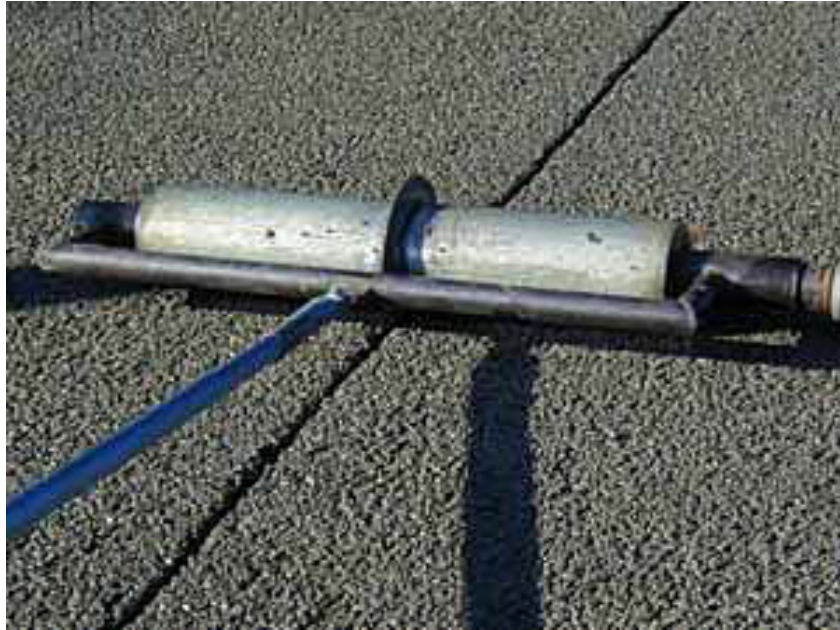
Figure 43: Roller Used to Create Joints in Pervious Concrete
